Sewall Wetland Consulting, Inc.

RE: Critical Area Report – Wildwood Ranch City of Cle Elum,
Washington
SWC Job #23-174

This report describes our observations of any jurisdictional wetlands or streams and/or buffers on or within 200' of Parcels #623134 & #063034 located south of Deer Meadow Drive in the City of Cle Elum, Washington (the "site").

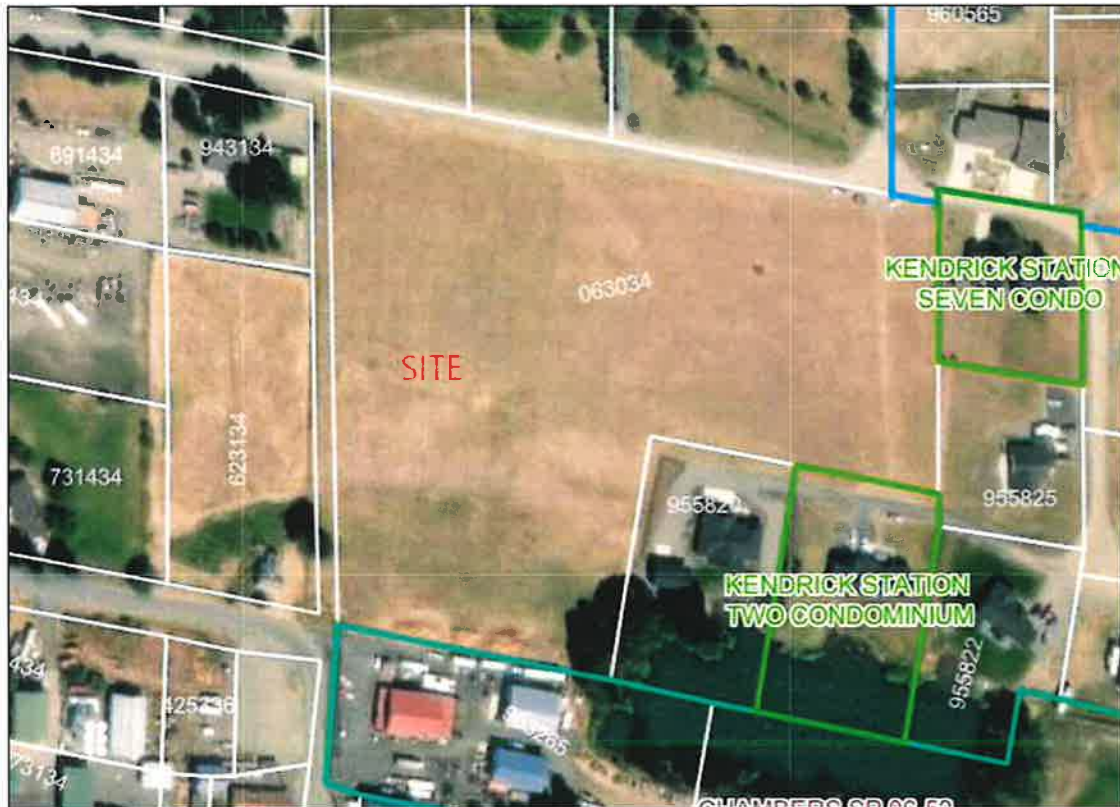
The site consists of two abutting, irregular shaped parcels, with a total area of 11.74 acres located within the SE ¼ of Section 25, Township 20 North, Range 15 East of the W.M. The site consists of mowed pasture and a vacant single family home on the southwest portion of the site.

Above: 2015 aerial photograph of the site from Kittitas Taxgifter website

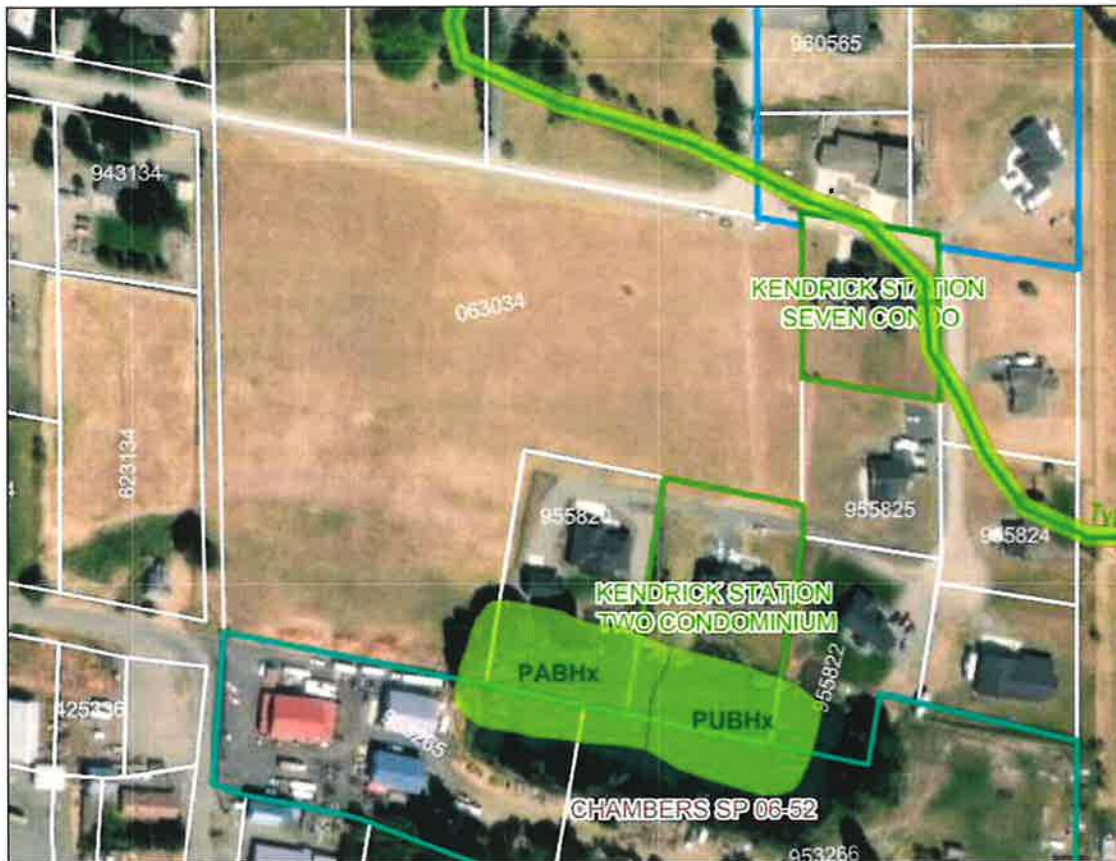
The Kittitas County Taxsifter website with wetland, stream and floodplain layers activated depicts the man-made pond on the southeast corner of the site as an unconsolidated bottom pond. In addition, a Type F water is depicted north of the site and Deer Meadow Drive.

Above: Kittitas County TaxsiFTER website with wetland and stream layers.

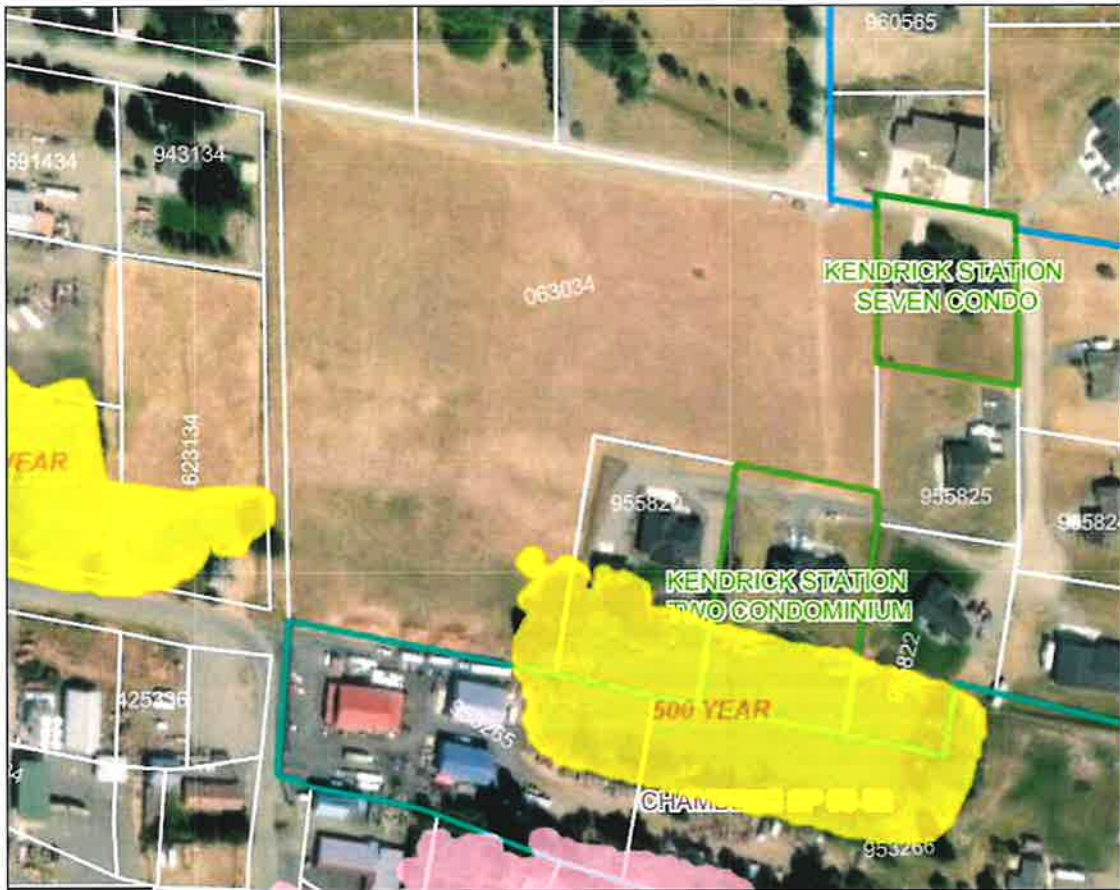
Above: Kittitas County Taxgifter website with floodplain layer.

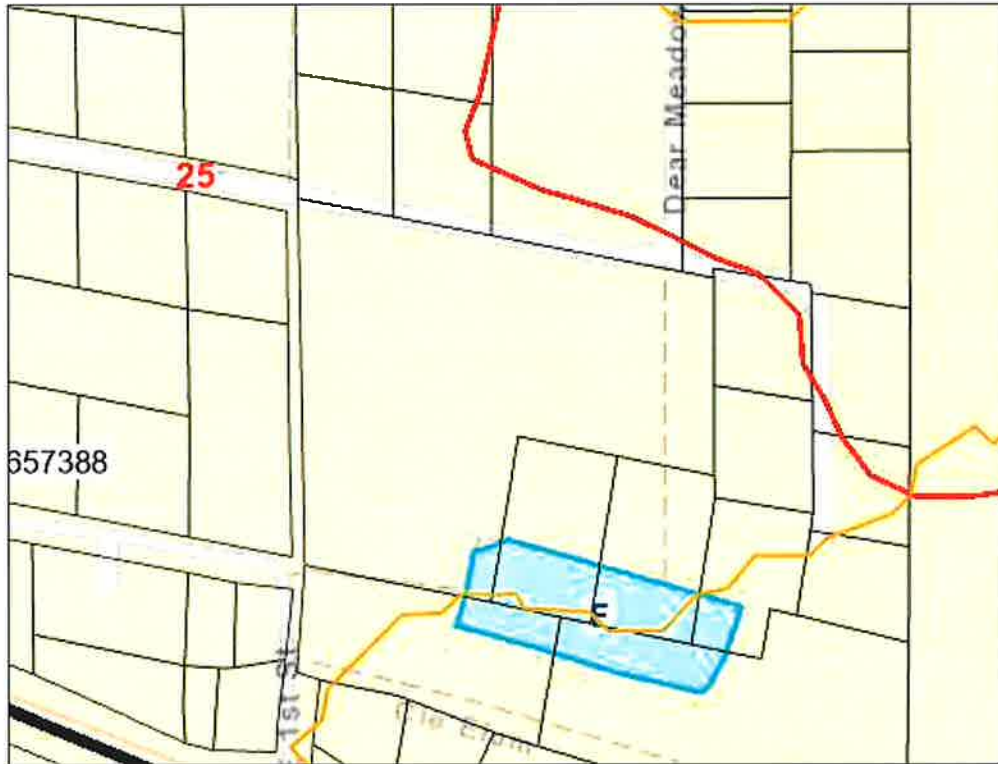
According to the WADNR Fpars Stream Type mapping website, the pond located on the southeast corner is depicted as a fish bearing pond, and the stream off-site to the north is depicted as a Type F water.

Above: WDNR Fpars water type mapping of the site.

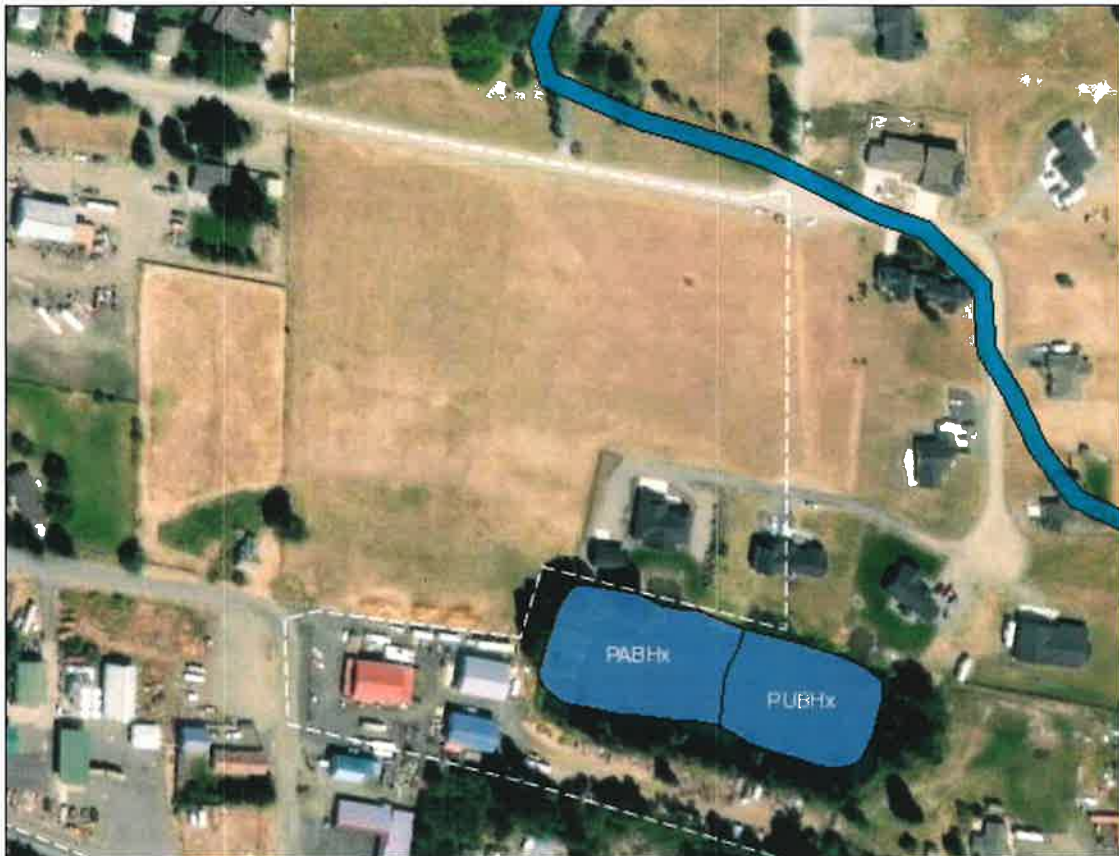
According to the NWI mapping of the site, the same features depicted on the County website are shown. This mapping was never field verified by USFWS and is a 1983 aerial photograph interpretation of wetlands. It should be noted the county mapping is a re-depiction of these features shown on the NWI map.

The wetlands and deepwater habitats in this area were photo interpreted using 1:58,000 scale, color infrared imagery from 1983.

Above: National Wetland Inventory Map of the site.

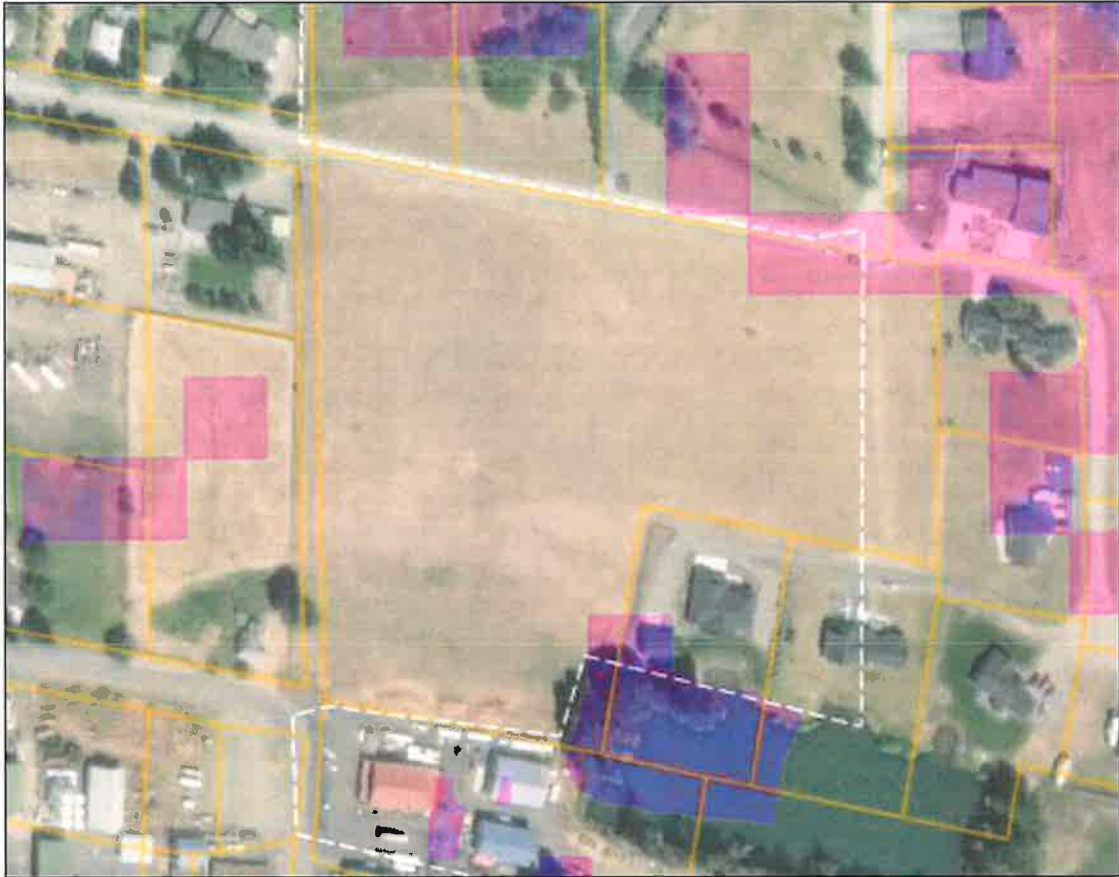
According to the WDFW Priority Habitat Website with Public access layers activated, the same features on the NWI mapping are shown. In addition the site is in a Township in which the sharp-tailed snake occurs, as well as the Northern Spotted Owl. The site area depicted as potential shrub steppe in scattered rectangular shapes which do not coincide with any current landscape feature on the site.

Above: WDFW Priority Habitats and Species Map of the area of the site.

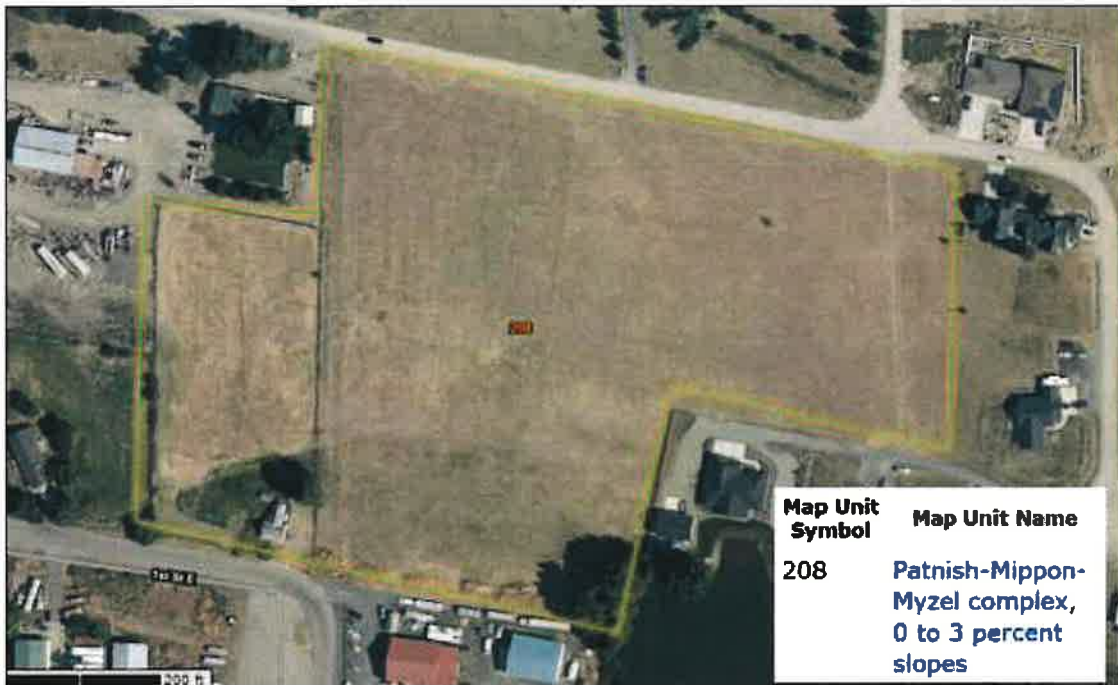
According to the NRCS soil mapping of the site, the site is mapped as Patnish-Mippon-Myzel complex soils. These are moderately well drained soils formed in alluvium with a mx of volcanic ash in the upper part. Patnish-Mippon-Myzel complex soils are not considered wetland or “hydric soils, according to the USDA SCS publication No. 1491 *“Hydric Soils of the United States”*”.

Above: NRCS Soil Survey Map of the site

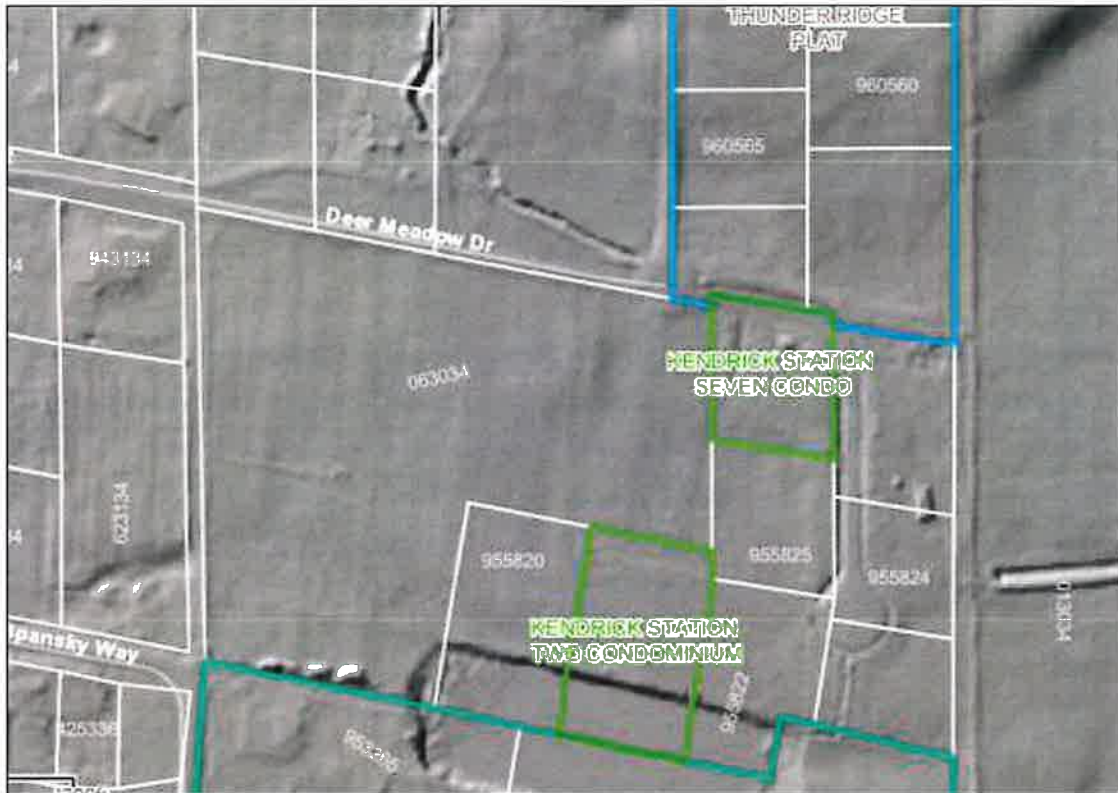
Above: Kittitas County Lidar depicting site topography.

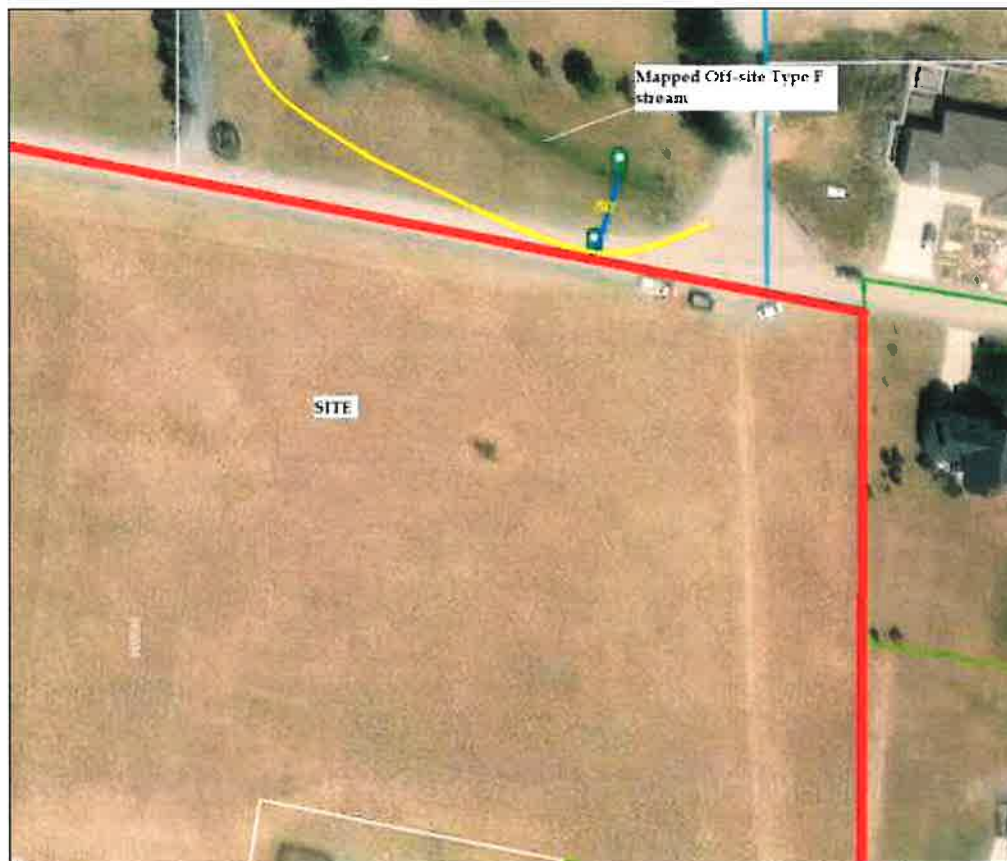
Off-site to the north of the site and Deer Meadow Drive, there is a mapped Type F stream. We did not have access to this site but an apparent swale is evident.

The characteristics of the channel are unknown but the various inventories identify it as a Type F water.

According to Table 18.01-5, Type F streams in the City of Cle Elum have a 50' buffer measured from the OHWM of the stream. This 50' buffer does not appear to extend onto the site.

Above: Depiction of the location of the Type F stream located off-site to the north.
