June 21, 2021  
PanGEO Project No. 21-269

Subject: GEOTECHNICAL FEASIBILITY STUDY  
East 3<sup>rd</sup> Street and Deer Meadow Drive, Cle Elum, Washington  
Kittitas County Parcel No. 063034

**GEOTECHNICAL FEASIBILITY STUDY  
EAST 3<sup>RD</sup> STREET AND DEER MEADOW DRIVE  
KITTTAS COUNTY PARCEL NO. 063034  
CLE ELUM, WASHINGTON**

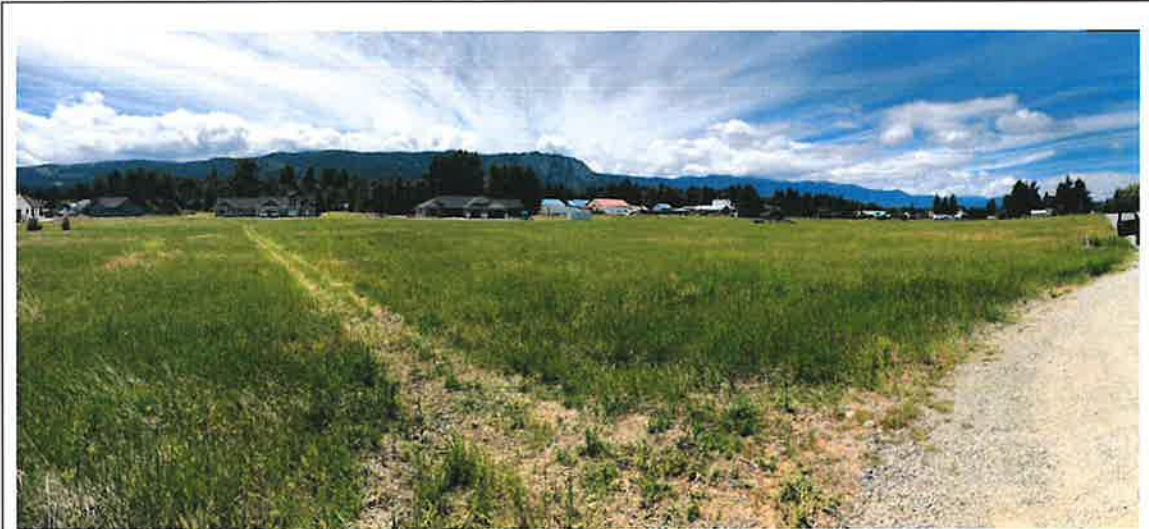
**Plate 1** – Panoramic view from intersection of East 3<sup>rd</sup> Street and Deer Meadow Drive. Facing south/southwest from northeast portion of the site.

Topography at the site slopes very gently down to the south at an average gradient of less than 2 percent. Based on topographic information available on Google Earth, there is up to about 10 feet of vertical feet between the north and south property lines. The site is

vegetated with tall grass. A view of the current site conditions can be seen in Plate 1 below.

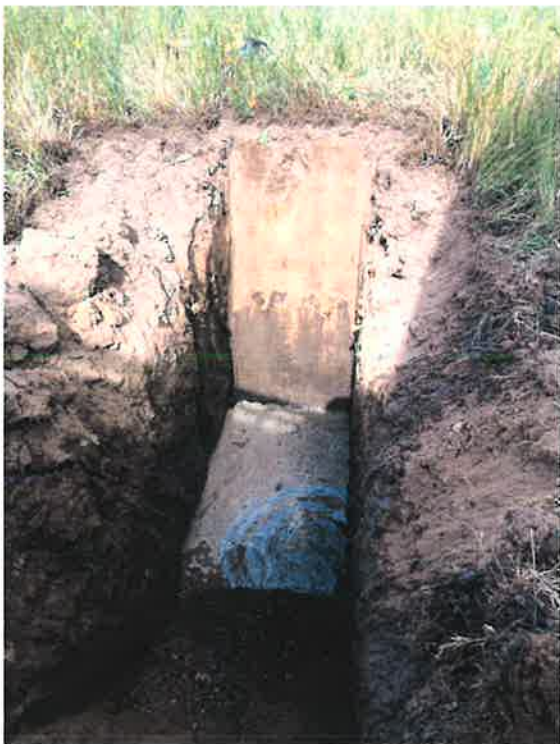
<u>Depth (ft)</u>	<u>Soil Description</u>
0 - 1	Medium dense, light brown, silty fine SAND, dry to moist. <b>[Fill]</b>
1 - 4¼	Medium stiff, brown to dark brown, slightly clayey SILT with sand, moist. <b>[Fine Alluvium]</b> <ul style="list-style-type: none"> <li>• Contains fine roots</li> <li>• Increase in moisture with depth</li> </ul>
4¼ - 5	Medium dense to dense, brown, poorly graded GRAVEL with sand, moist to wet. <b>[Coarse Alluvium]</b> <ul style="list-style-type: none"> <li>• Groundwater encountered around 4½ feet below ground surface</li> <li>• Heavy caving below groundwater</li> </ul>

Completed test pit.

Test Pit TP-1 terminated about 8 feet below grade.  
Groundwater was encountered about 4½ feet below grade.

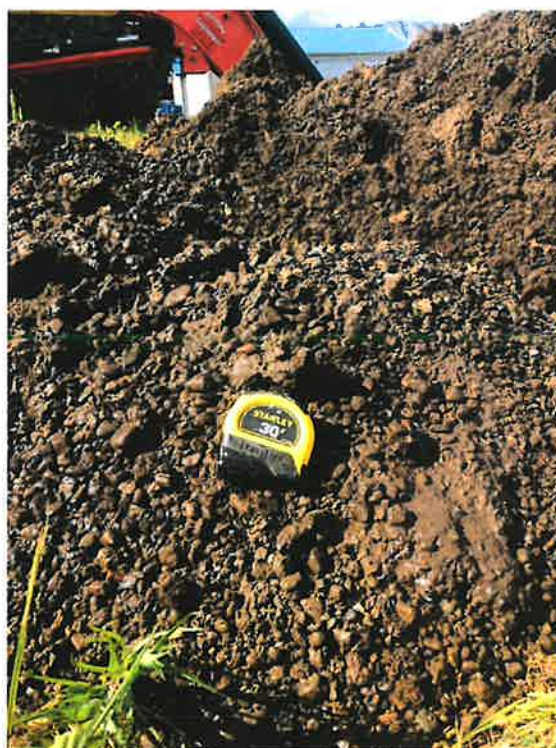
Coarse alluvium test pit spoils.

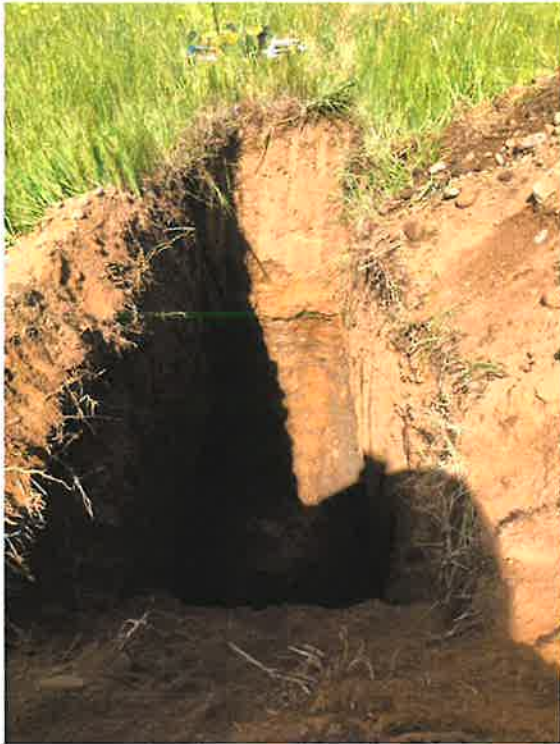
<u>Depth (ft)</u>	<u>Soil Description</u>
0 – 4	Medium stiff, brown to dark brown, slightly clayey SILT, moist. [ <b>Fine Alluvium</b> ] <ul style="list-style-type: none"> <li>• Contains fine roots, trace sand</li> <li>• Increase in moisture with depth</li> </ul>
4 – 7½	Medium dense to dense, brown, poorly graded GRAVEL with sand, moist. [ <b>Coarse Alluvium</b> ] <ul style="list-style-type: none"> <li>• Contains cobbles, moderate caving</li> <li>• Groundwater encountered around 7 feet below ground surface</li> <li>• Heavy caving below groundwater</li> </ul>

Completed test pit.

Test Pit TP-2 terminated about 7½ feet below grade.  
 Groundwater was encountered about 7 feet below grade.

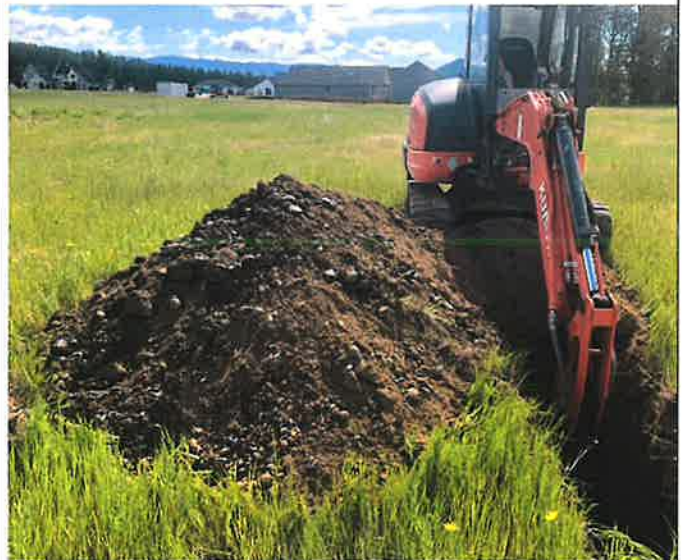
Test pit spoils.

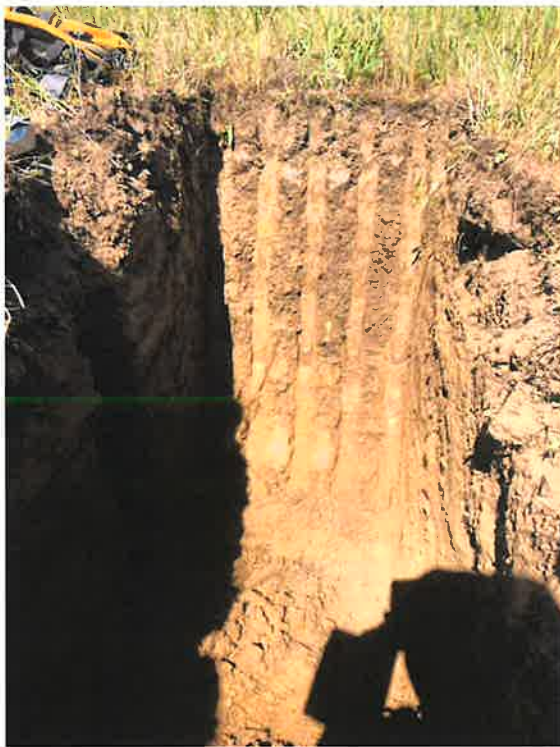
<u>Depth (ft)</u>	<u>Soil Description</u>
0 – 6	Medium stiff, brown to dark brown, slightly clayey SILT, moist. [ <b>Fine Alluvium</b> ] <ul style="list-style-type: none"> <li>• Contains fine roots, trace sand</li> <li>• Increase in moisture with depth</li> </ul>
6 – 8½	Medium dense to dense, brown, poorly graded GRAVEL with sand, moist. [ <b>Coarse Alluvium</b> ] <ul style="list-style-type: none"> <li>• Contains cobbles, moderate caving</li> <li>• Groundwater encountered around 8 feet below ground surface</li> <li>• Heavy caving below groundwater</li> </ul>

Test pit at 4 feet deep, fine alluvium.

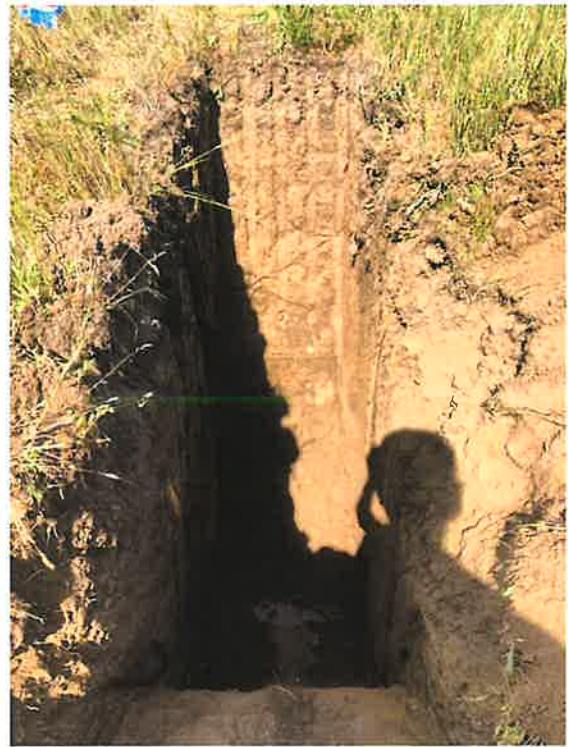
Completed test pit.

Test Pit TP-3 terminated about 8½ feet below grade.  
 Groundwater was encountered about 8 feet below grade.

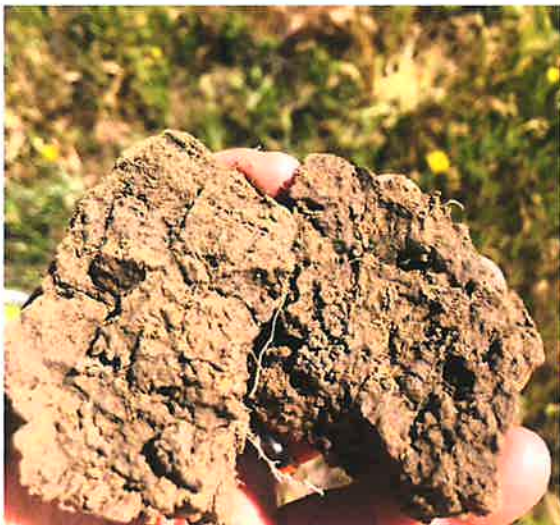
<u>Depth (ft)</u>	<u>Soil Description</u>
0 – 5	Medium stiff, brown to dark brown, slightly clayey SILT, moist. <b>[Fine Alluvium]</b> <ul style="list-style-type: none"> <li>• Contains fine roots, trace sand, occasional gravel</li> </ul>
5 – 7	Medium dense, brown, poorly graded GRAVEL with silt and sand, moist. <b>[Coarse Alluvium]</b> <ul style="list-style-type: none"> <li>• Contains cobbles</li> </ul>
7 – 10	Medium dense to dense, brown, poorly graded GRAVEL with sand, moist. <b>[Coarse Alluvium]</b> <ul style="list-style-type: none"> <li>• Contains cobbles, slight caving</li> <li>• Becomes moist to wet around 9½ feet below ground surface, near groundwater table</li> </ul>

Fine alluvium from about 5 feet deep.

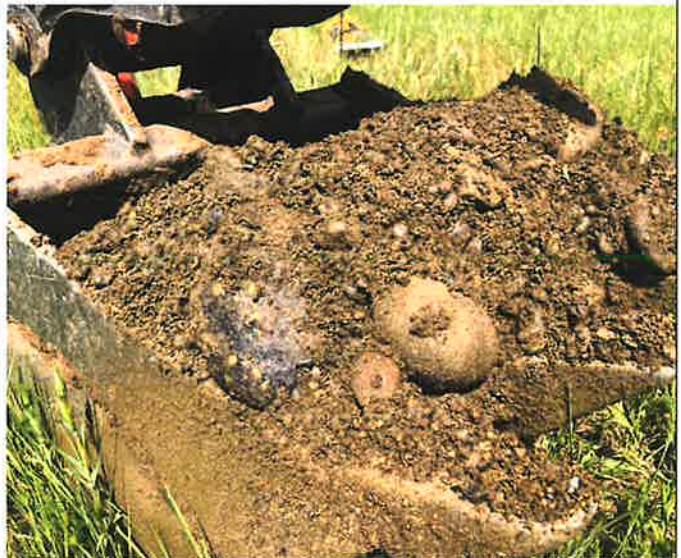
Coarse alluvium from about 9 feet deep.

Test Pit TP-4 terminated about 10 feet below grade.  
Groundwater was not encountered at the time of excavation.

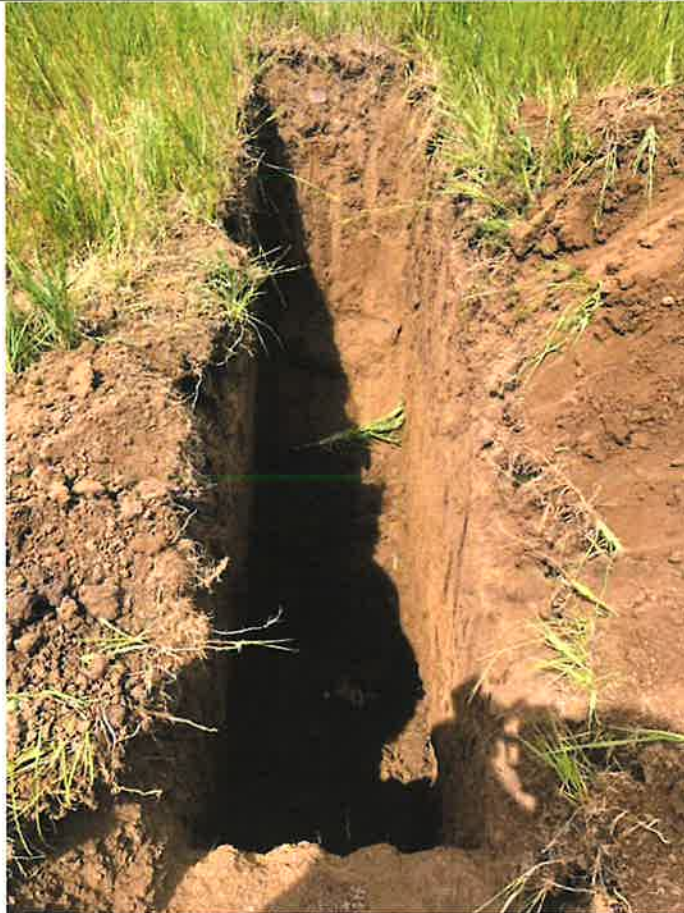
<u>Depth (ft)</u>	<u>Soil Description</u>
0 – 5	Medium stiff, brown to dark brown, slightly clayey SILT, moist. <b>[Fine Alluvium]</b> <ul style="list-style-type: none"><li>• Contains fine roots, trace sand</li><li>• Increase in moisture with depth</li></ul>
5 – 8	Medium dense to dense, brown, poorly graded GRAVEL with sand, moist. <b>[Coarse Alluvium]</b> <ul style="list-style-type: none"><li>• Contains cobbles</li><li>• Groundwater encountered around 7½ feet below ground surface</li></ul>

Completed test pit.

Test Pit TP-5 terminated about 8 feet below grade.

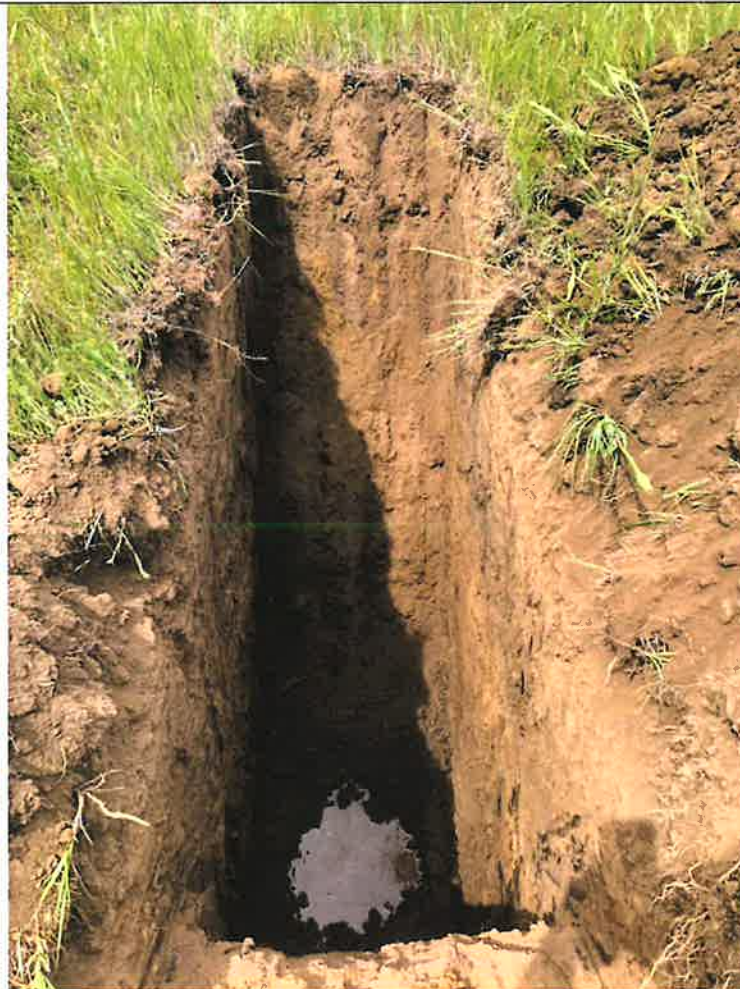
<u>Depth (ft)</u>	<u>Soil Description</u>
0 – 5	Medium stiff, brown to dark brown, slightly clayey SILT, moist. [ <b>Fine Alluvium</b> ] <ul style="list-style-type: none"><li>• Contains fine roots, trace sand, occasional gravel</li></ul>
5 – 7	Medium dense to dense, brown, poorly graded GRAVEL with sand, moist. [ <b>Coarse Alluvium</b> ] <ul style="list-style-type: none"><li>• Contains cobbles</li><li>• Groundwater encountered around 6½ feet below ground surface</li></ul>

Completed test pit.

Test Pit TP-6 terminated about 7 feet below grade.

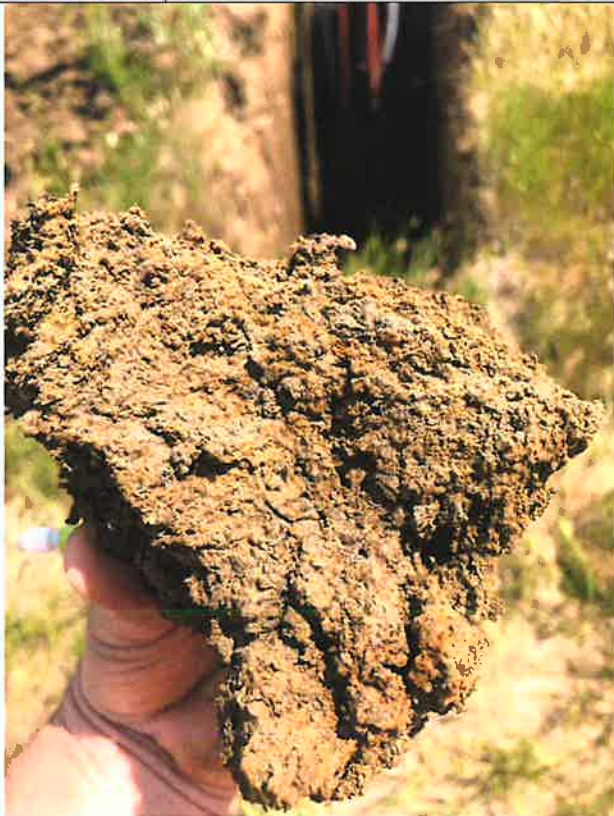
<u>Depth (ft)</u>	<u>Soil Description</u>
0 – 9	Medium stiff, brown to dark brown, slightly clayey SILT, moist. <b>[Fine Alluvium]</b> <ul style="list-style-type: none"> <li>• Contains fine roots, trace sand</li> <li>• Increase in moisture around 6 feet below grade</li> <li>• Becomes mottled around 7 feet below grade, moist to wet fine sand seams</li> </ul>

Mottled fine alluvium from about 7 feet deep.

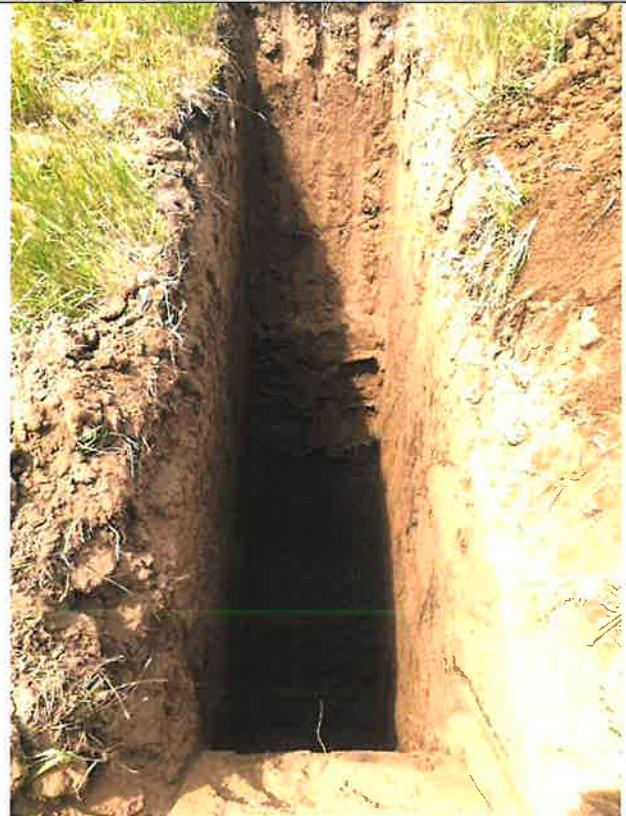
Completed test pit.

Test Pit TP-7 terminated about 9 feet below grade.  
Groundwater was not encountered at the time of excavation.
