July 30, 2024 (*revised November 21, 2024*)
File No. 24-228

Subject: Infiltration Test Report
Proposed Bullfrog Apartments
4240 Bullfrog Road, Cle Elum, Washington

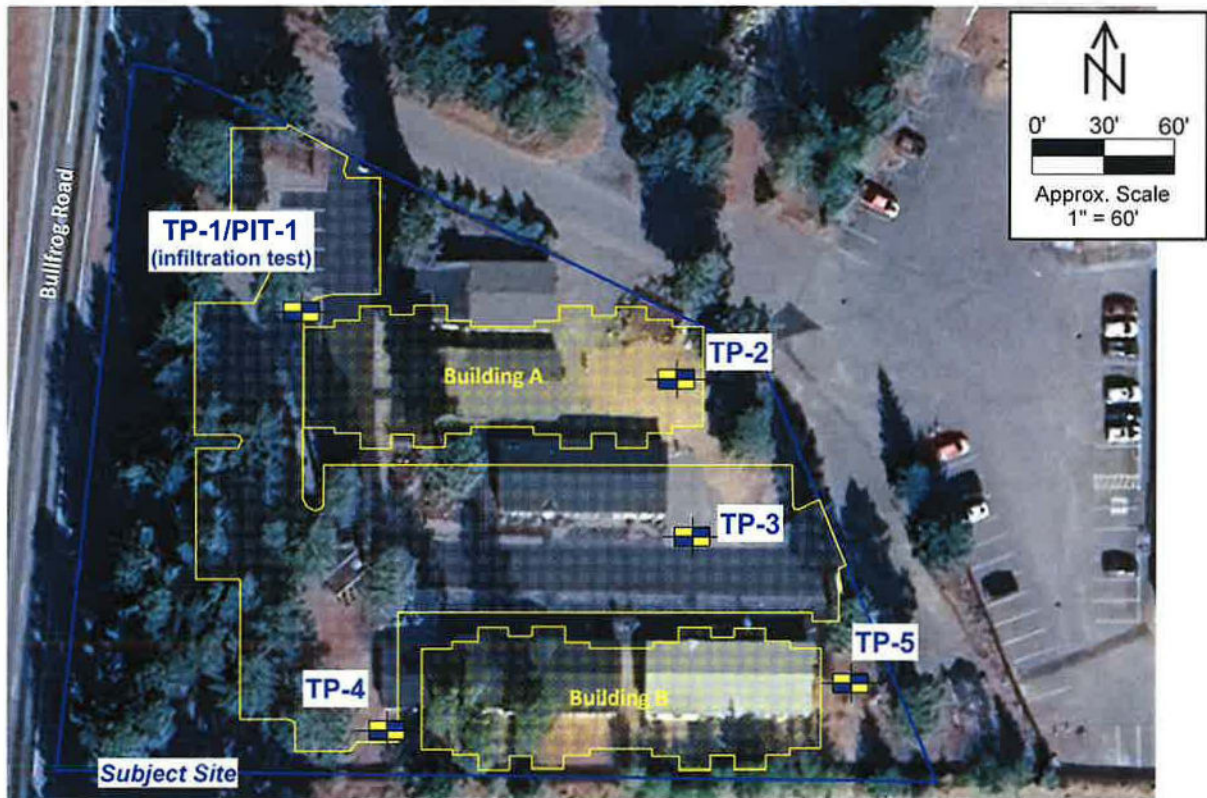
SITE AND EXPLORATION PLAN

Notes: Base map obtained from Google Earth. Proposed building layout 'Option B'.

Approximate Test Pit Location

We understand that infiltration facilities may be installed as part of the proposed development, if feasible. Based on preliminary information provided by the project civil engineer, the proposed infiltration system may consist of dry wells or infiltration trenches in drive areas. The approximate layout of the proposed development is shown in Figure 2, Site and Exploration Plan.

Five test pits (TP-1 through TP-5) were excavated at the subject site on June 25, 2024, to evaluate subsurface conditions. The approximate test pit locations are indicated in Figure 2. The test pits were excavated up to 9 feet below the existing ground surface using a Kubota U27 rubber tracked mini-excavator owned and operated by Tamarack Trail Builders of Roslyn, Washington. The field exploration was overseen by a geologist with our firm who logged and sampled the soils encountered in the test pits.
