Wildwood/#23-174

Sewall Wetland Consulting, Inc.

WILDWOOD RANCH PLAT

WILDWOOD RANCH PRELIMINARY PLAT
PREPARED FOR
JEFF STUBBS

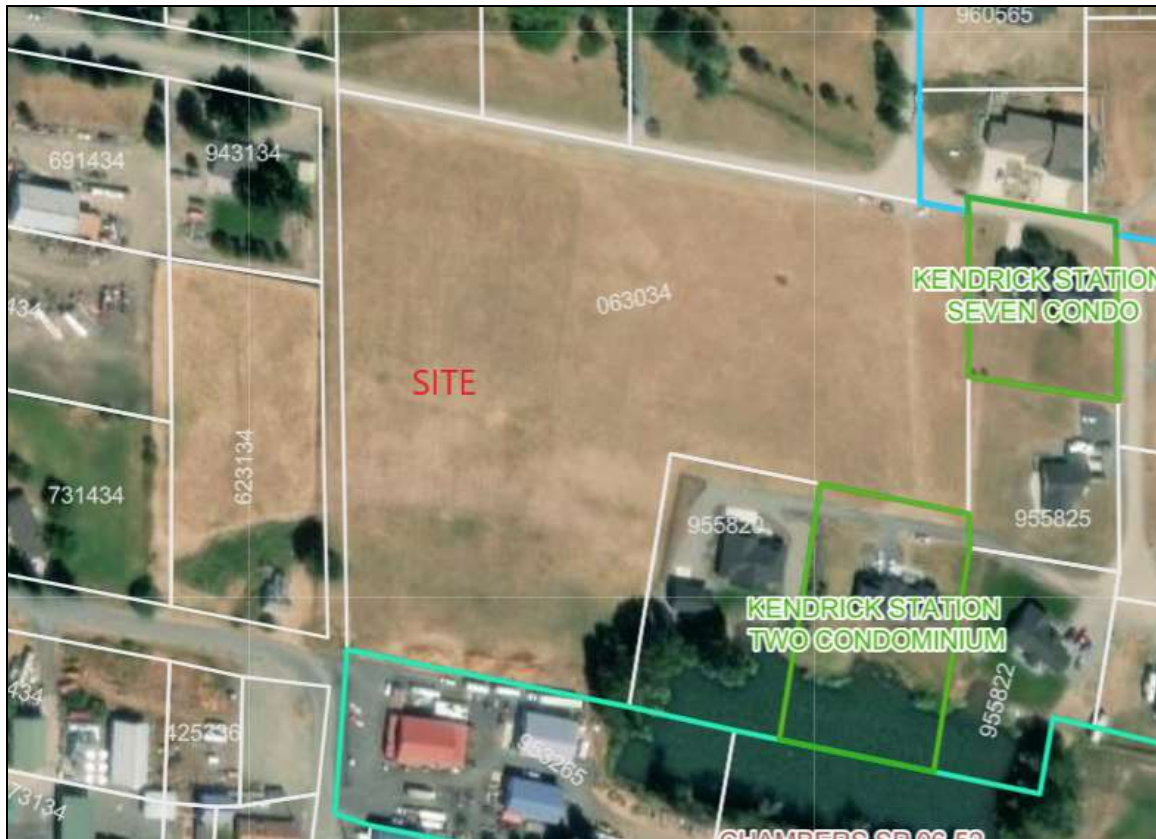
The site consists of two abutting, irregular shaped parcels, with a total area of 11.74 acres located within the SE ¼ of Section 25, Township 20 North, Range 15 East of the W.M. The site consists of mowed pasture and a vacant single family home on the southwest portion of the site.

Above: 2015 aerial photograph of the site from Kittitas Taxsifter website

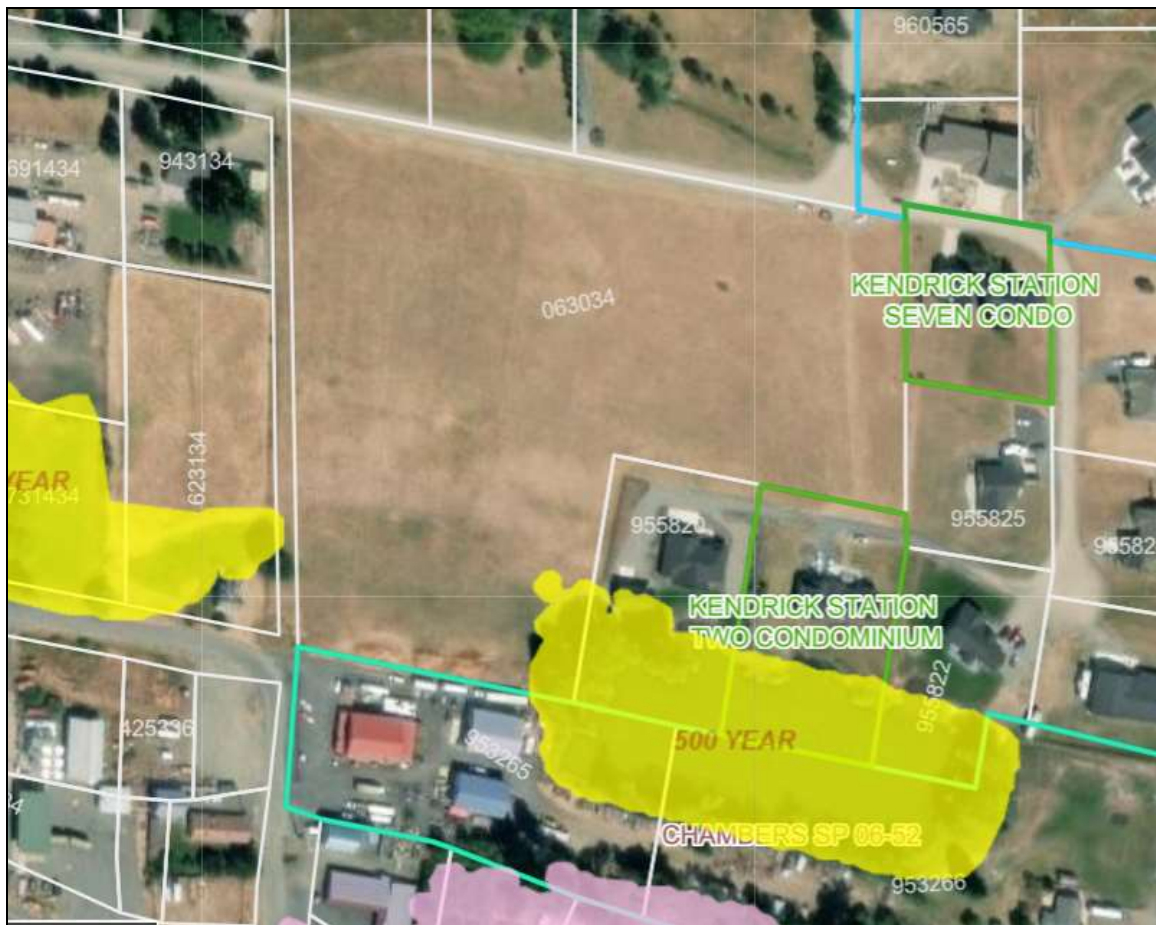
Above: Kittitas County TaxsiFTER website with floodplain layer.

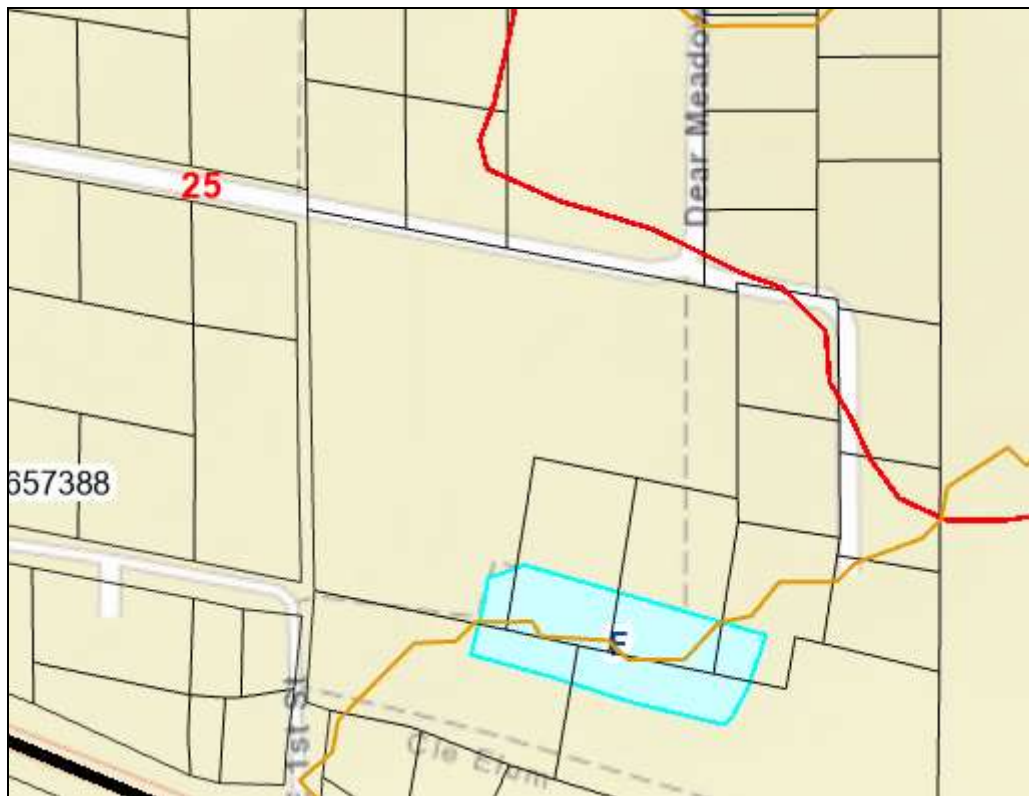
According to the WADNR Fpars Stream Type mapping website, the pond located on the southeast corner is depicted as a fish bearing pond, and the stream off-site to the north is depicted as a Type F water.

Above: WDNR Fpars water type mapping of the site.

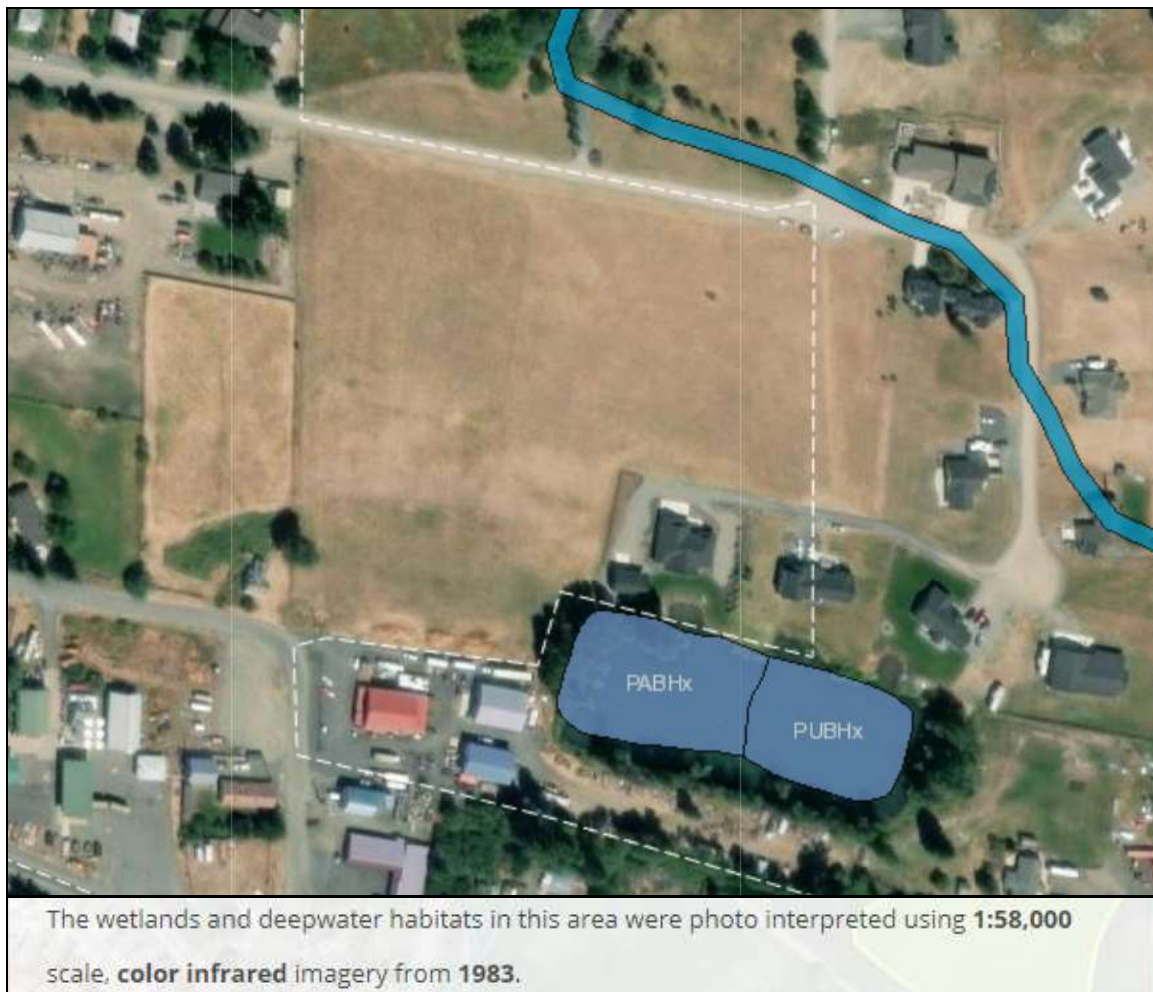
According to the NWI mapping of the site, the same features depicted on the County website are shown. This mapping was never field verified by USFWS and is a 1983 aerial photograph interpretation of wetlands. It should be noted the county mapping is a re-depiction of these features shown on the NWI map.

Above: National Wetland Inventory Map of the site.

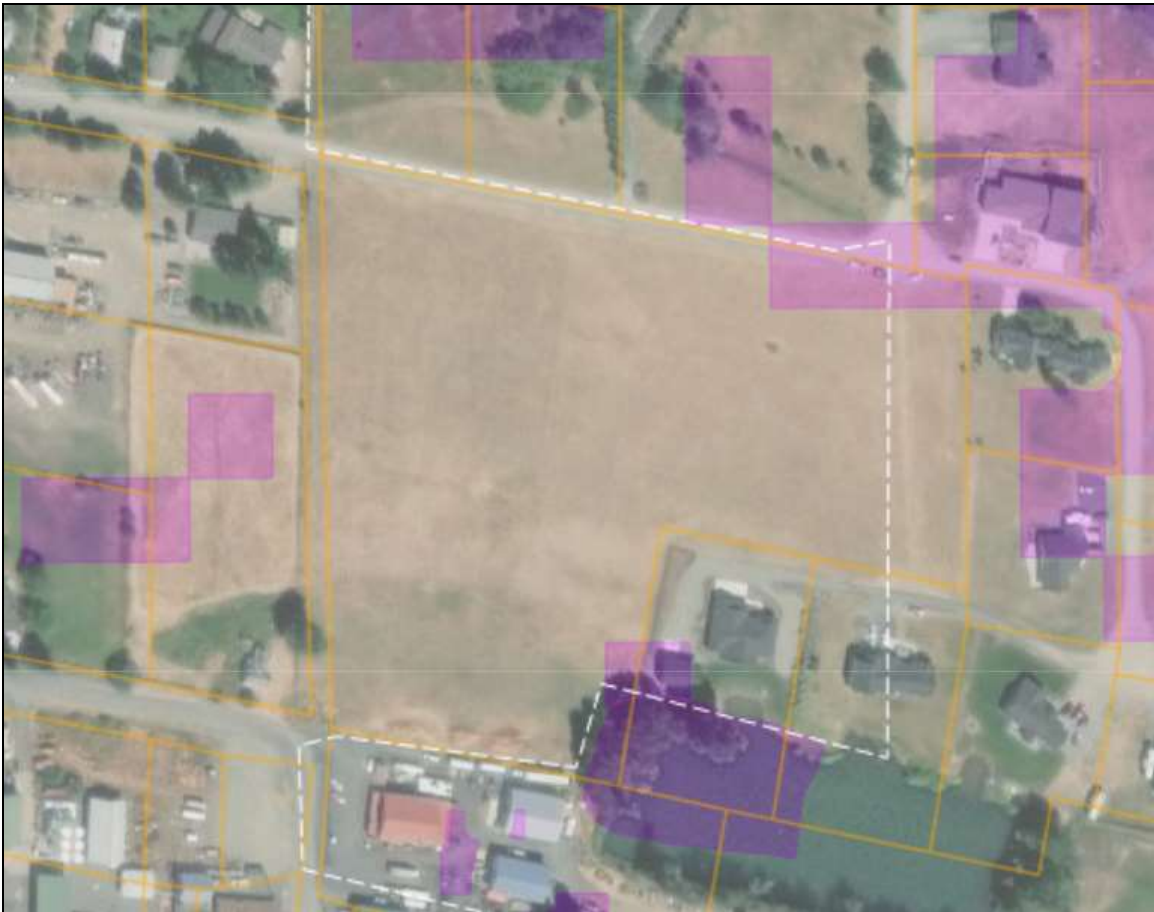
According to the WDFW Priority Habitat Website with Public access layers activated, the same features on the NWI mapping are shown. In addition the site is in a Township in which the sharp-tailed snake occurs, as well as the Northern Spotted Owl. The site area depicted as potential shrub steppe in scattered rectangular shapes which do not coincide with any current landscape feature on the site.

Above: WDFW Priority Habitats and Species Map of the area of the site.

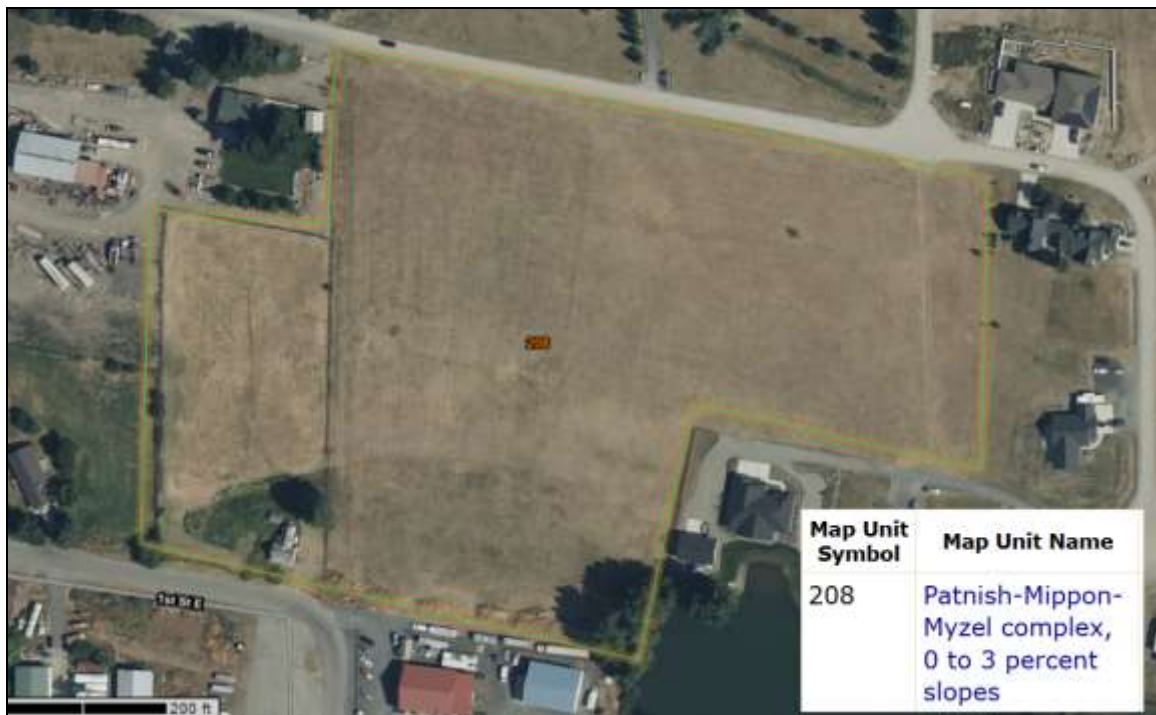
According to the NRCS soil mapping of the site, the site is mapped as Patnish-Mippon-Myzel complex soils. These are moderately well drained soils formed in alluvium with a mx of volcanic ash in the upper part. Patnish-Mippon-Myzel complex soils are not considered wetland or “hydric soils, according to the USDA SCS publication No. 1491 *“Hydric Soils of the United States”*.

Above: NRCS Soil Survey Map of the site

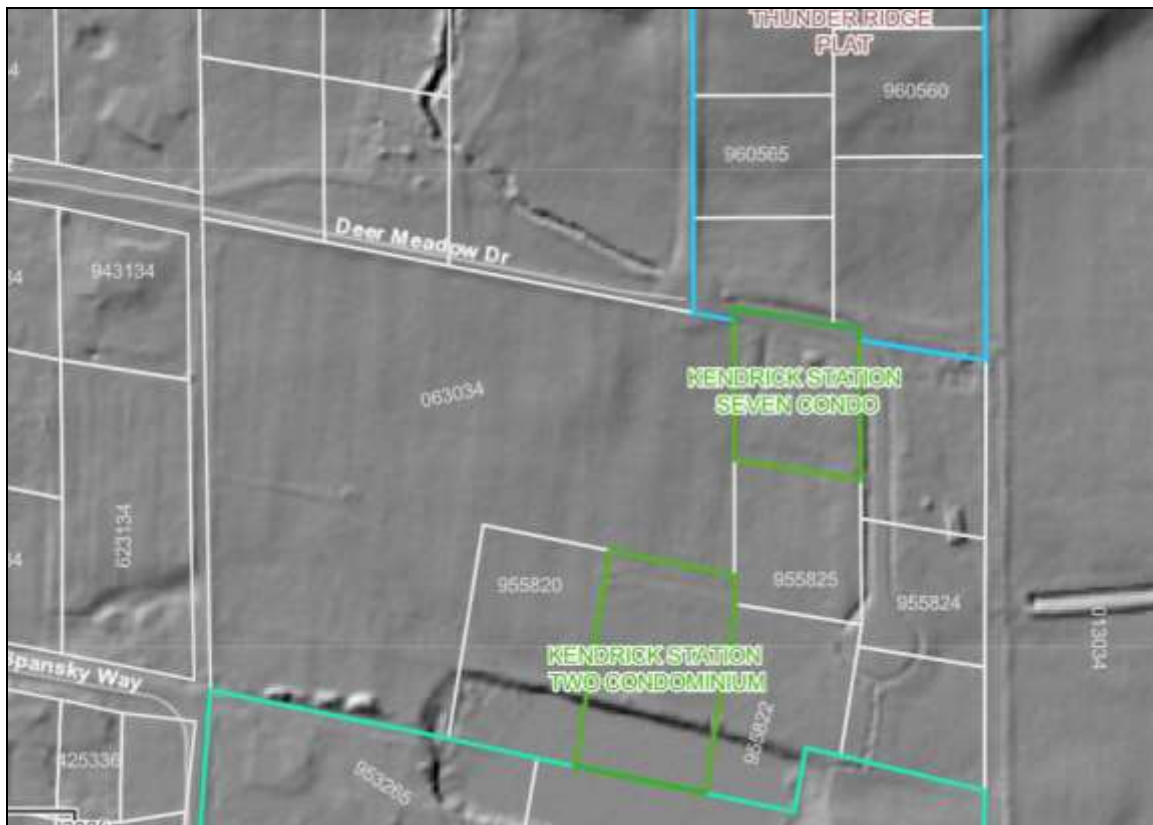
The site consists of a large mowed pasture on the north and east with a vacant single family home with several outbuildings on the south west corner of the site. A man-made pond is located along the southeast corner of the site. Scattered cottonwood and rose are found along the edge of the pond which was drawn down at the time of our fieldwork to a cobble bottom feature with some ponded water.

Above: Kittitas County Lidar depicting site topography.

The man-made pond is an old borrow pit and clearly a man-made feature. Generally man-made ponds are not regulated as wetlands or jurisdictional waters.

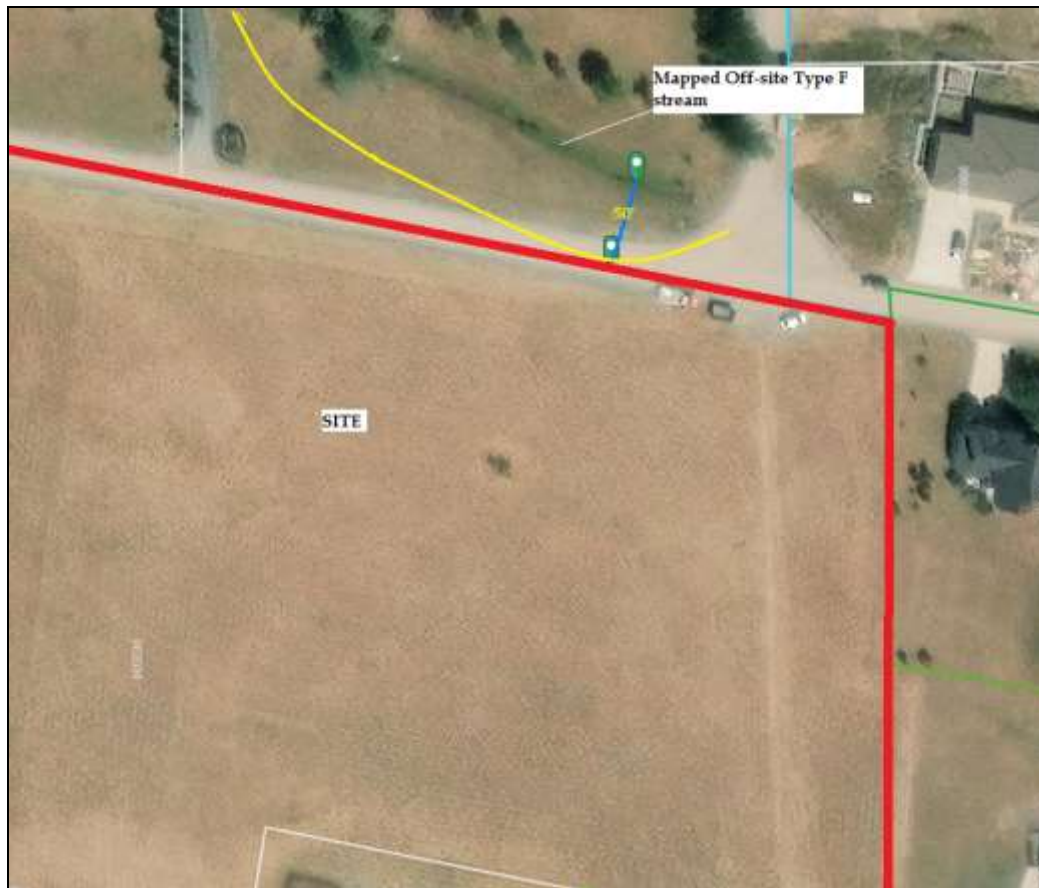
Off-site to the north of the site and Deer Meadow Drive, there is a mapped Type F stream. We did not have access to this site but an apparent swale is evident.

The characteristics of the channel are unknown but the various inventories identify it as a Type F water.

According to Table 18.01-5, Type F streams in the City of Cle Elum have a 50' buffer measured from the OHWM of the stream. This 50' buffer does not appear to extend onto the site.

Above: Depiction of the location of the Type F stream located off-site to the north.
