# Geotechnical Engineering Services Report Update 1

HopeSource Cle Elum  
Cle Elum, Washington

October 10, 2025

File No. 27639-001-00  
October 10, 2025

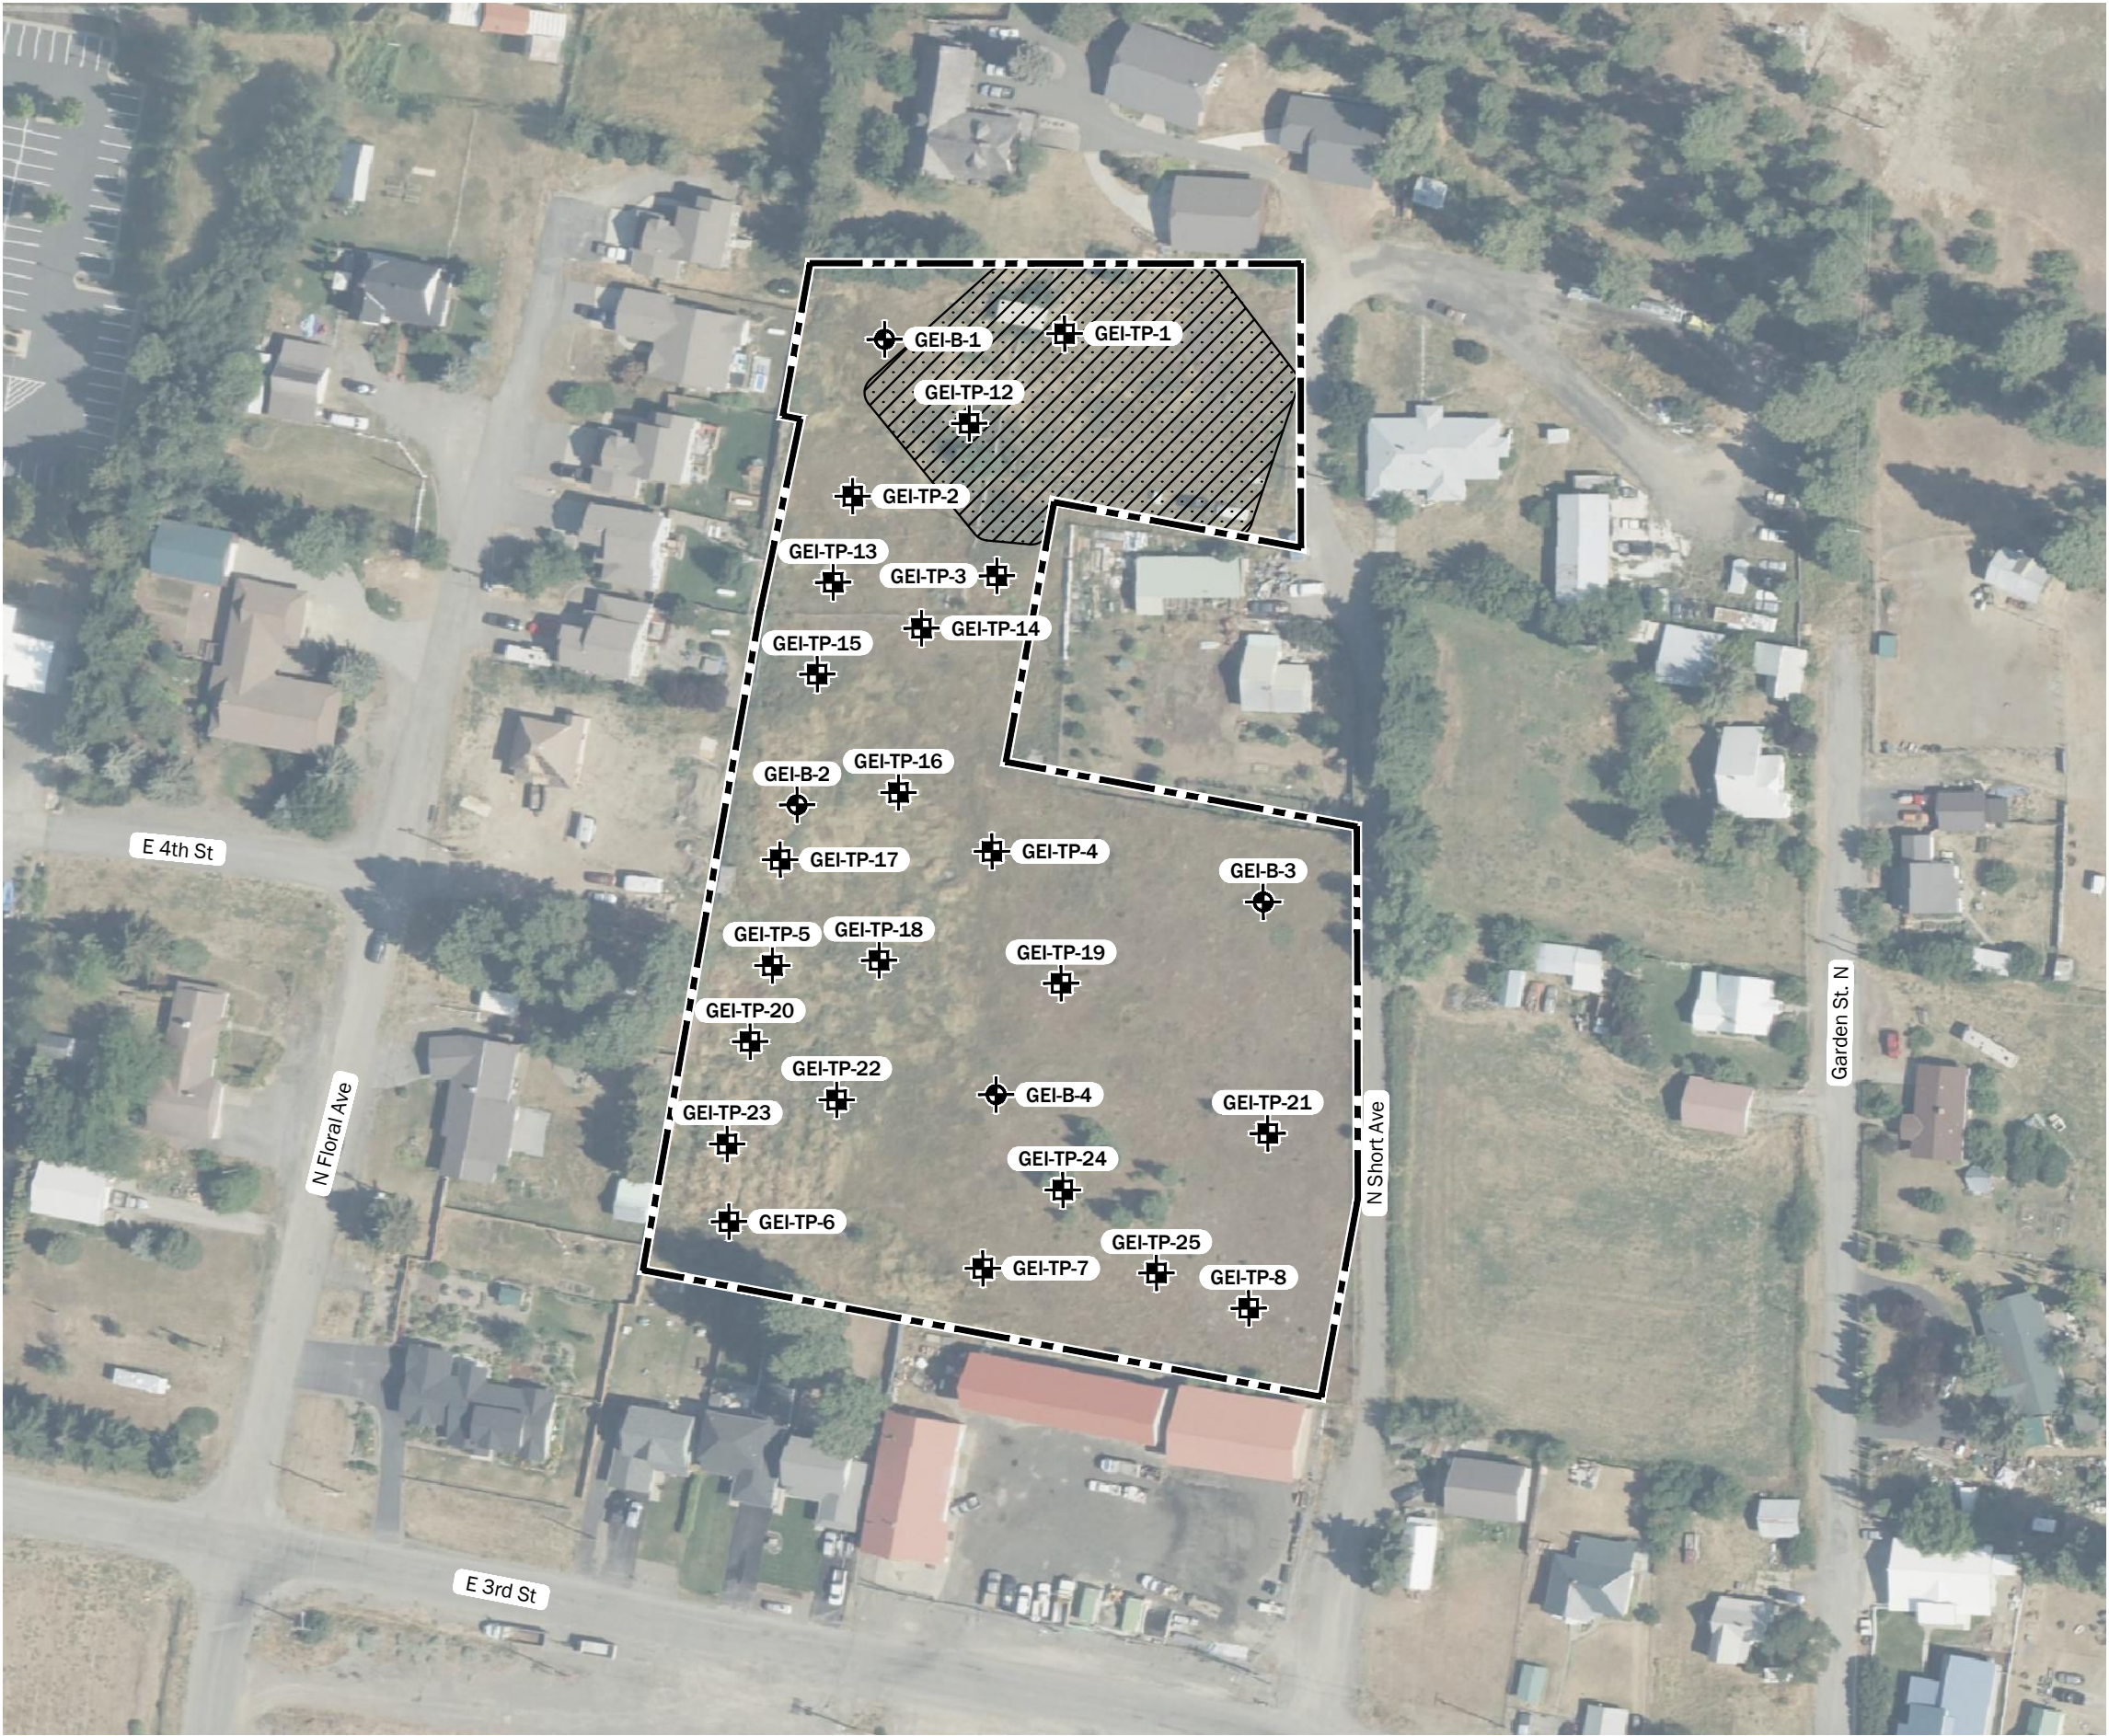
| | <b>Figure 2</b> |

- Legend**
- Site Boundary
  - GEI-B-1 Boring by GeoEngineers
  - GEI-TP-1 Test Pit by GeoEngineers
  - Approximate Extents of Debris Field

**Note:**  
GEI-TP-9 through GEI-TP-11 were not completed as there were multiple test pits completed within the debris fill area.

The subsurface conditions at the site were evaluated by drilling four borings (GEI-B-1 through GEI-B-4) and excavating 22 test pits (GEI-TP-1 through GEI-TP-8 and GEI-TP-12 through GEI-TP-25). Numerous other test pits were completed at the north end of the site to help delineate the extent of the debris fill in that area. GEI-TP-9 through GEI-TP-11 did not include prepared test pit logs as they were completed within the fill debris delineation area. The borings were drilled to depths ranging from 21½ to 31 feet below existing site grades and the test pits were excavated to depths ranging from 6½ to 9 feet below existing site grades. The approximate locations of the explorations were recorded by measuring from known site features and are shown on Figures 2 through 4. A detailed description of the field exploration program and the summary exploration logs are presented in Appendix A.

- **Sod/Topsoil.** Approximately 4 to 6 inches of sod and topsoil was observed in the test pits that were excavated in the grass areas on the site.
- **Fill.** Fill was observed in test pit GEI-TP-1 and boring GEI-B-2. The fill extended from ground surface to approximately 3 feet below site grades in test pit GEI-TP-1 and consisted of reworked soils containing glass, wood, and concrete debris. This area is located at the northern end of the project site and was further evaluated during a second mobilization (including GEI-TP-12 and other test pits unlabeled and included on Figure 4) that observed these soils extended across a significant footprint. The extents and depth are summarized in Figures 2 through 4. Boring GEI-B-2 encountered some ash debris at a depth of approximately 5 feet, which was interpreted to be fill soils. This area was also further explored during the second mobilization with GEI-TP-17 which observed wood debris within the soils located in the upper approximately 2½ feet of the test pit.

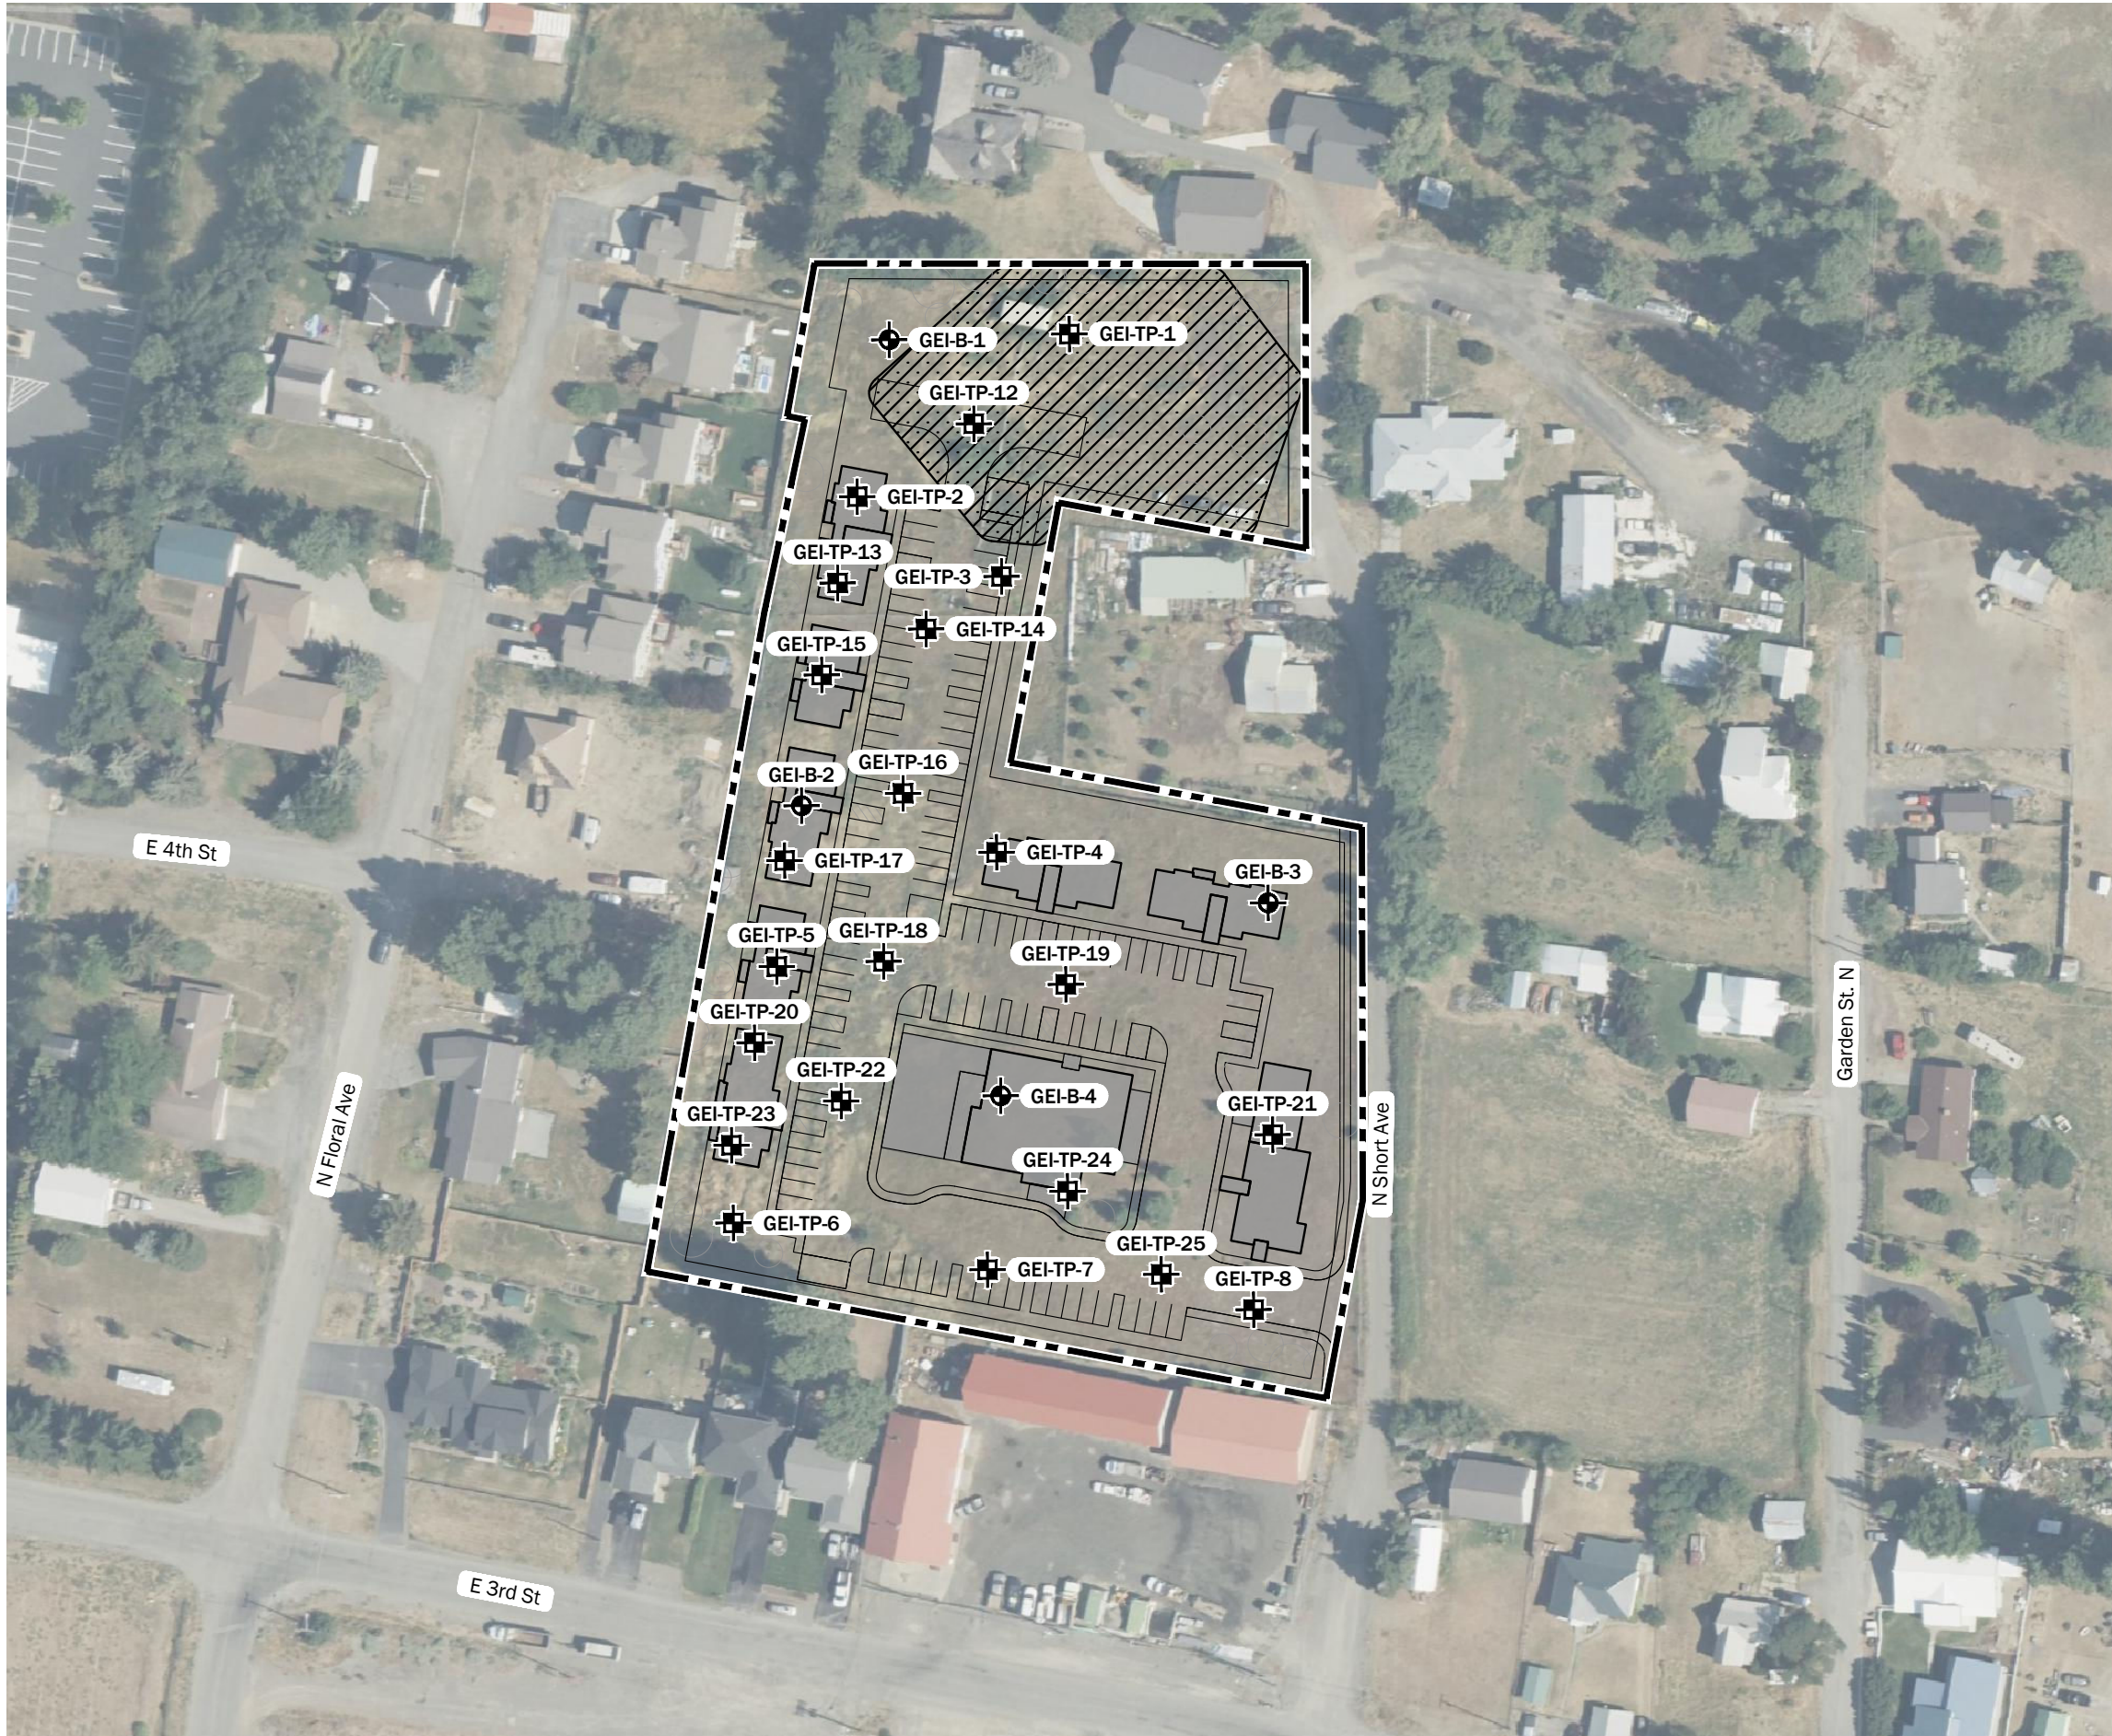
Figure 3

- Site Boundary
- GEI-B-1 Boring by GeoEngineers
- GEI-TP-1 Test Pit by GeoEngineers
- Approximate Extents of Debris Field

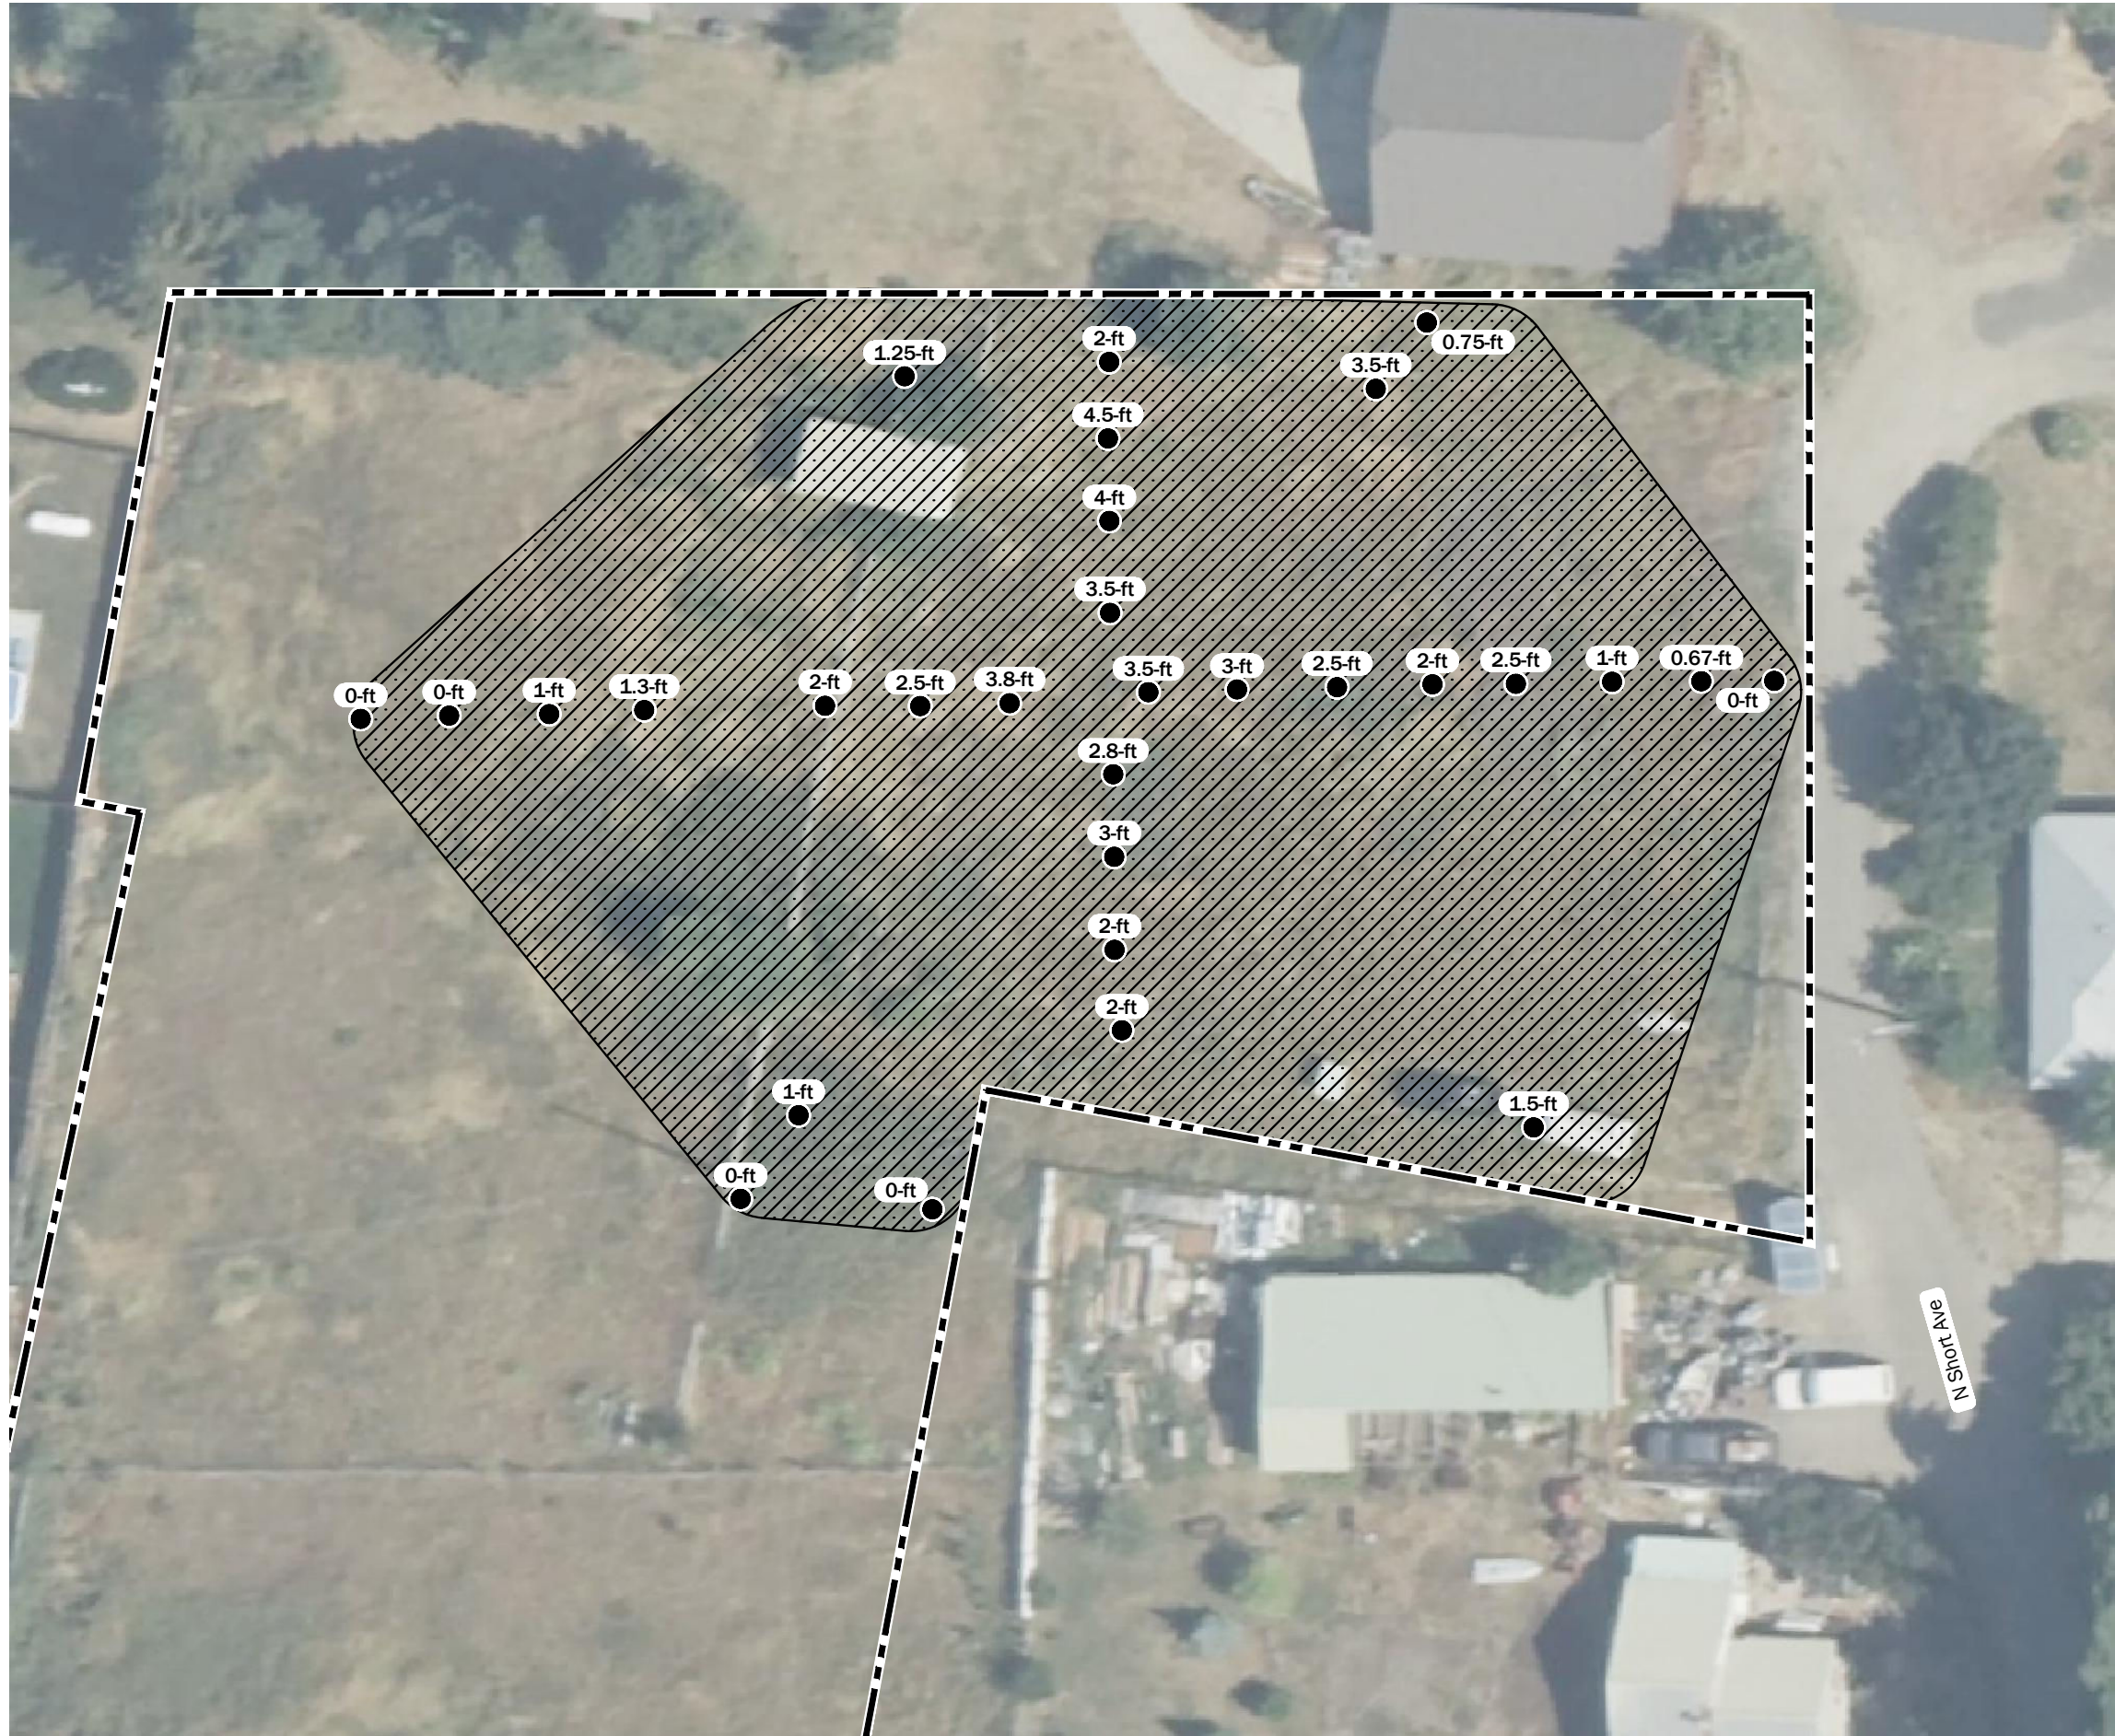
Figure 4

- Legend**
- Site Boundary
  - Approximate Depth of Debris Fill Encountered in Test Pit
  - Approximate Extents of Debris Fill

Based on the subsurface soil conditions encountered in the explorations, we expect that the soils at the site can be excavated using conventional construction equipment. Deeper cuts may require a large, heavy-duty excavator to accomplish the excavations. The contractor should be prepared to deal with cobbles, if encountered, as well as miscellaneous debris (glass, wood, metal, concrete, etc.) in the existing on-site fill. The north end of the project site includes a large area of fill soil containing debris. The approximate extents of the debris fill is shown in Figure 4.

Fill was encountered to a depth of 3 feet in test pit GEI-TP-1 and to a depth of 7 feet in boring GEI-B-2. The fill observed in GEI-TP-1 included deleterious debris such as concrete, glass and wood. We anticipate that fill soils may also be present in other areas of the site. Additionally, there are what appear to be fill embankments along the south edge of the western boundary near GEI-B-2 and GEI-TP-6 that appear raised from nearby site grades. The fill material with debris should be removed and disposed of offsite.
