# GEOTECHNICAL REPORT

## Proposed Bullfrog Apartments

### 4240 Bullfrog Road

PROJECT NO. 24-228  
July 2024

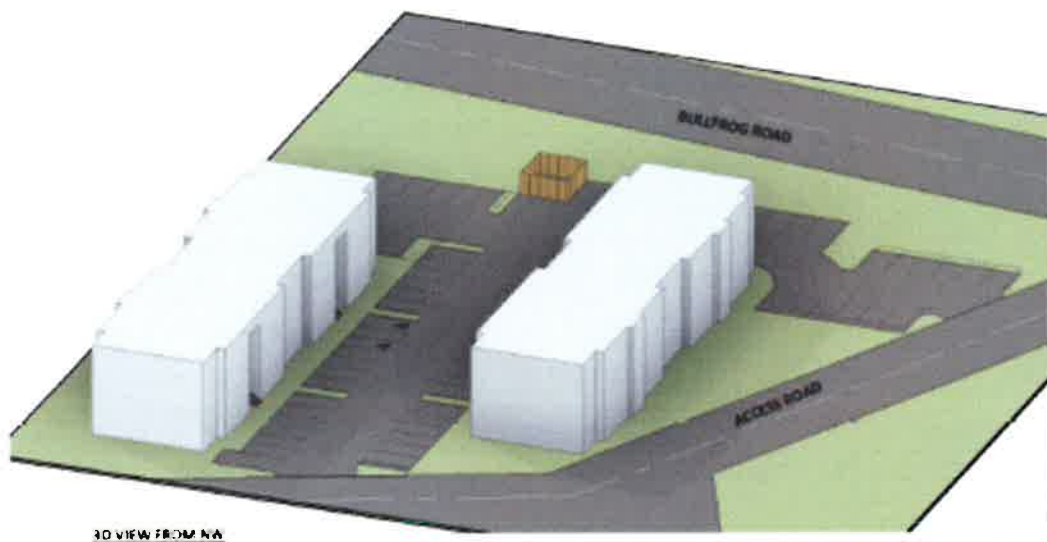
Site Plan – Option 2 Rendering by Runberg Architecture Group

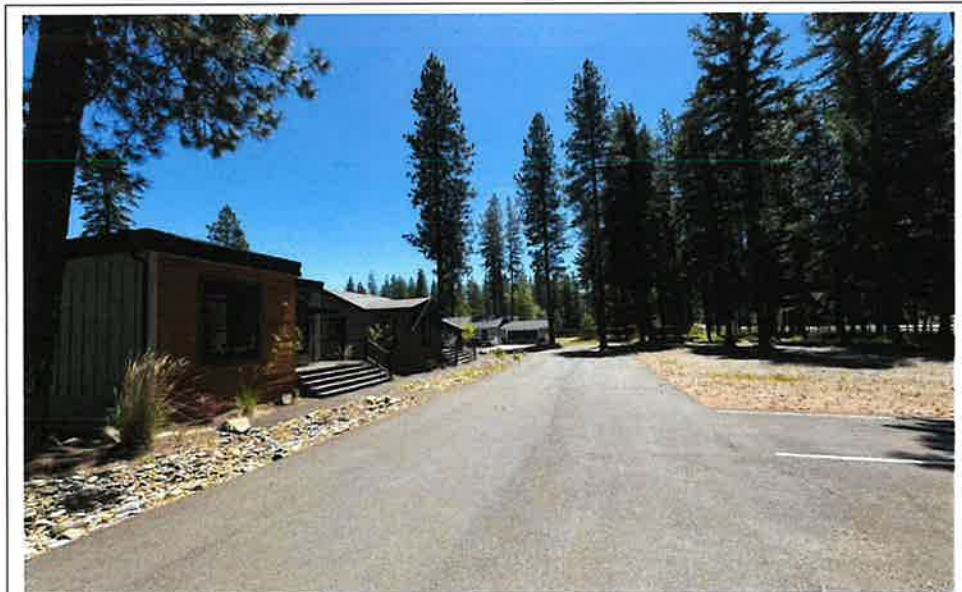
*Plate 1 – Facing south from the site entrance in the northwest portion of site.*

The project site is an approximately 1.72-acre lot located at 4240 Bullfrog Road in Cle Elum, Washington (see Figure 1, Vicinity Map). The site is bound by an asphalt paved access drive to the north, by Bullfrog Road to the west, and by Cle Elum-Roslyn school district properties to south and east. Based on our field observations, the existing site grade is generally level. The site is currently occupied by multiple one-story model homes and an asphalt paved roadway that passes through the site. Existing site conditions at the time of our fieldwork are shown in Plate 1, below.

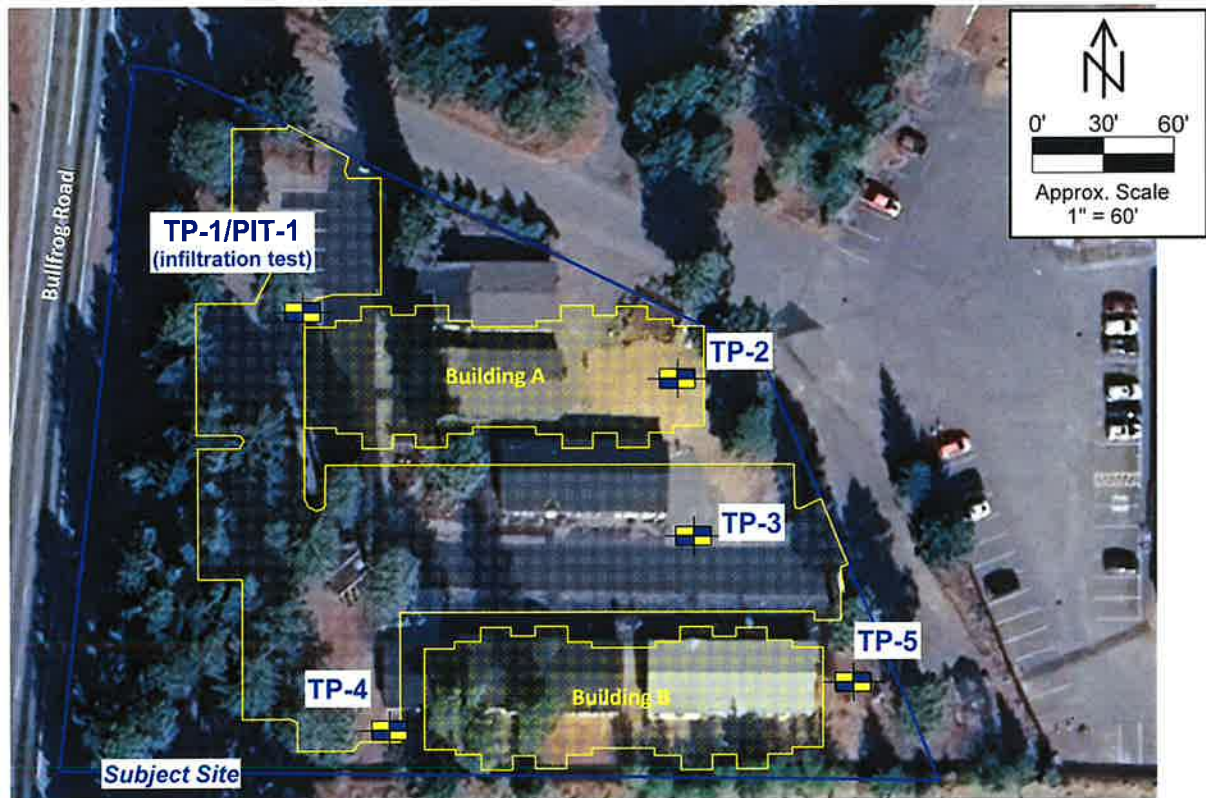
Figure No. **2**

Notes: Base map obtained from Google Earth. Proposed building layout 'Option B'.

Five test pits (TP-1 through TP-5) were excavated at the subject site on June 25, 2024, to evaluate subsurface conditions. The approximate test pit locations are indicated in Figure 2. The test pits were excavated up to 9 feet below the existing ground surface using a Kubota U27 rubber tracked mini-excavator owned and operated by Tamarack Trail Builders of Roslyn, Washington.

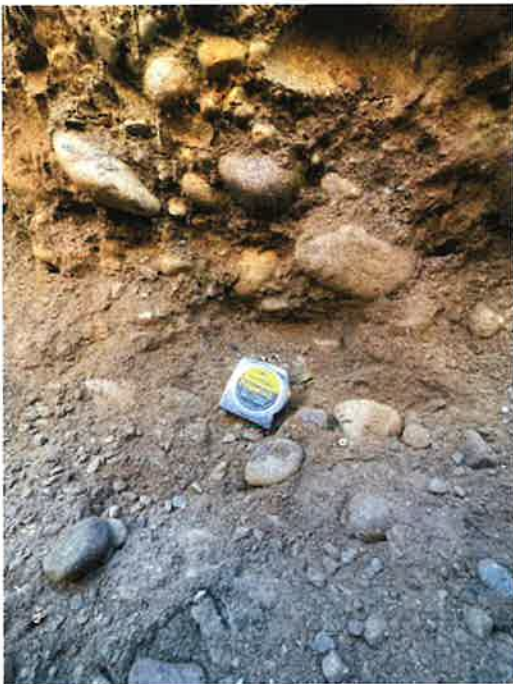
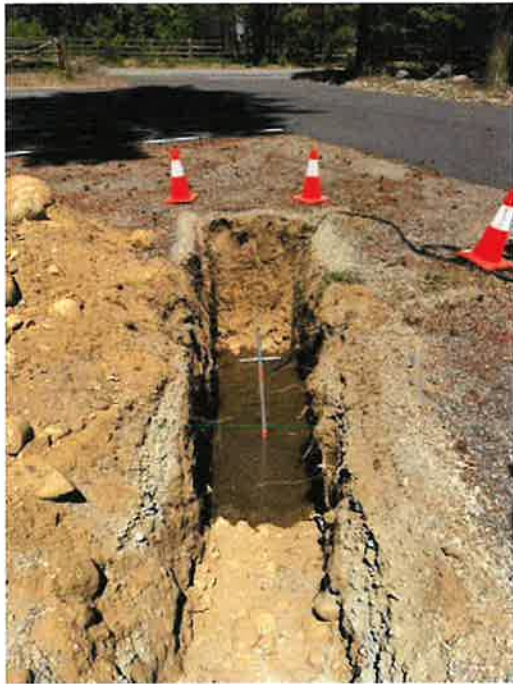
4.5 – 9	Medium dense to dense, brown, poorly graded GRAVEL with silt and sand, moist. <ul style="list-style-type: none"> <li>Small-scale Pilot Infiltration Test conducted about 5 feet below grade</li> <li><b>Sample at 5:</b> 5.0% fines (GP-GM)</li> <li>Numerous cobbles, occasional small boulders</li> <li>Minor caving</li> </ul>
<div>

</div> <p><b>Left Photo:</b> Tape measure at about 5 feet below grade. <b>Right Photo:</b> Infiltration test in progress.</p> <p>TP-1 was terminated approximately 9 feet below grade at the conclusion of infiltration testing. Groundwater was not encountered at the time of excavation.</p> <p><b>Logged by:</b> S Swenson</p>

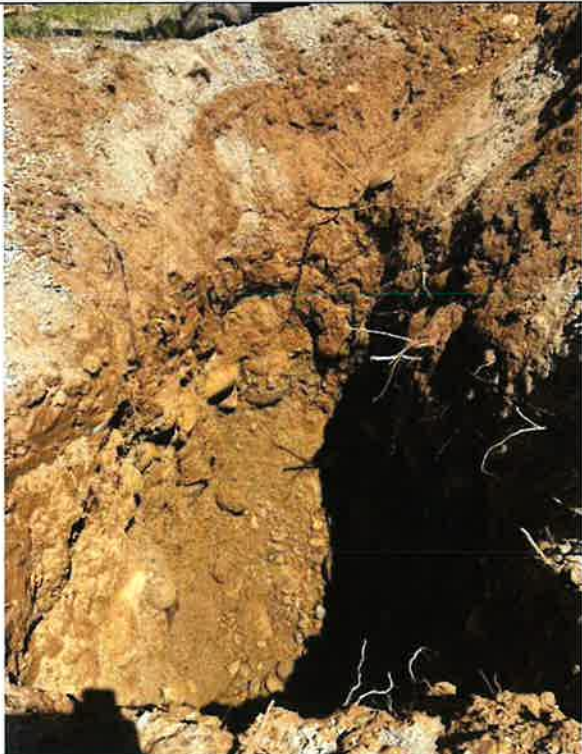
3.5 – 9	Dense, brown, well to poorly graded GRAVEL with sand, moist. <ul style="list-style-type: none"> <li>Numerous cobbles, occasional small boulders</li> <li><b>Sample at 5'</b>: 4.4% fines (GW)</li> <li><b>Sample at 8.5'</b>: 4.1% fines (GP)</li> </ul>
<p><b>Photo:</b> Test pit around 7 feet deep.</p> <p>TP-3 was terminated approximately 9 feet below grade due to practical excavation refusal on a boulder. Groundwater was not encountered at the time of excavation.</p> <p><b>Logged by:</b> S Swenson</p>

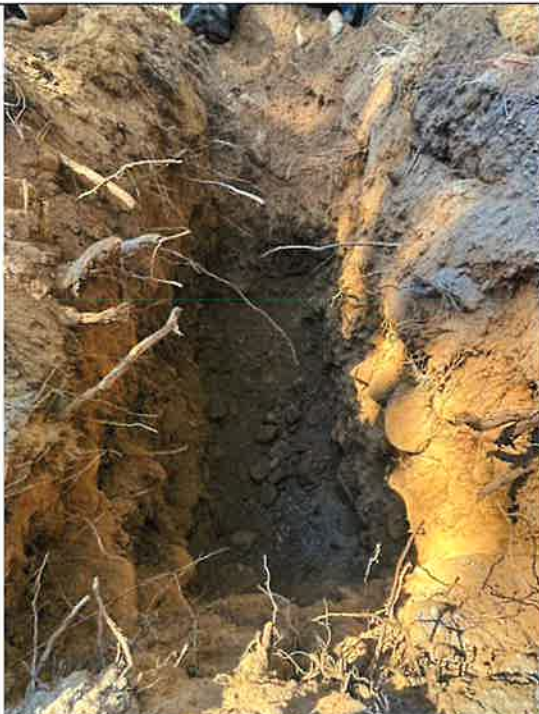
0.75 – 2	Loose to medium dense, silty fine SAND to sandy SILT, dry to moist, [Loess] <ul style="list-style-type: none"> <li>Numerous roots</li> <li>Sample at 1.5': 47.0% fines (SM)</li> </ul>
2 – 4	Medium dense to dense, brown, silty GRAVEL with sand, dry to moist. [Mainstream Alluvium] <ul style="list-style-type: none"> <li>Numerous cobbles, occasional small boulders</li> </ul>
4 – 8	Medium dense to dense, brown, well to poorly graded GRAVEL with sand, moist. <ul style="list-style-type: none"> <li>Numerous cobbles, occasional small boulders</li> </ul>
<p><b>Photo:</b> Completed test pit.</p> <p>TP-4 was terminated approximately 8 feet below grade. Groundwater was not encountered at the time of excavation.</p> <p><b>Logged by:</b> S Swenson</p>

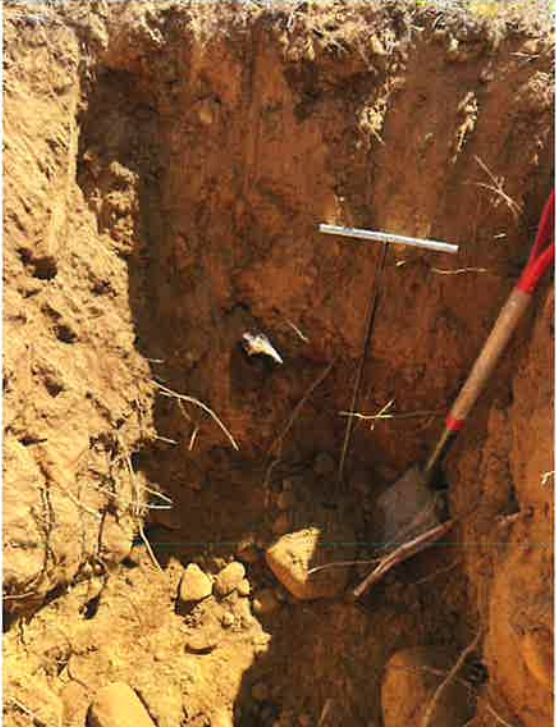
Test Pit No. TP-5	
Location: See Figure 2	
Approximate ground surface elevation: 2,126 feet	
Depth (ft)	Material Description
0 – 4	Loose to medium dense, silty fine SAND to sandy SILT, dry to moist, [Loess] <ul style="list-style-type: none"><li>Numerous roots</li></ul>
4 – 6.5	Medium dense to dense, brown, poorly graded GRAVEL with silt and sand, moist. [Alluvium] <ul style="list-style-type: none"><li>Numerous cobbles, occasional small boulders</li><li>Sample at 6': 5.5% fines</li></ul>
<p><b>Photo:</b> Test pit at 5 feet.</p> <p>TP-5 was terminated approximately 6.5 feet below grade. Groundwater was not encountered at the time of excavation.</p> <p><b>Logged by:</b> S Swenson</p>
