# GEOTECHNICAL REPORT

## Proposed Bullfrog Apartments

### 4240 Bullfrog Road

### Cle Elum, Washington

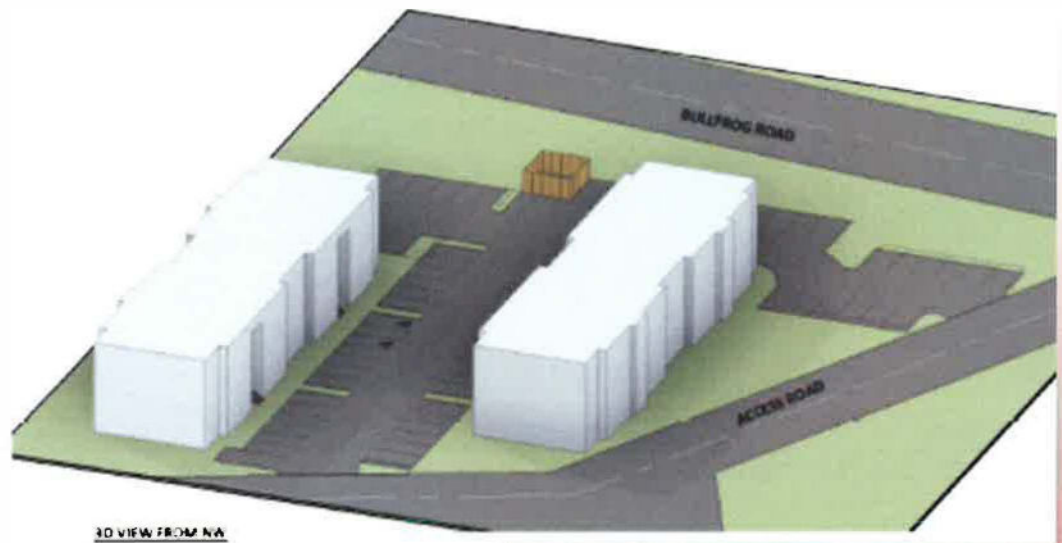
3D VIEW FROM NW

Site Plan – Option 2 Rendering by Runberg Architecture Group

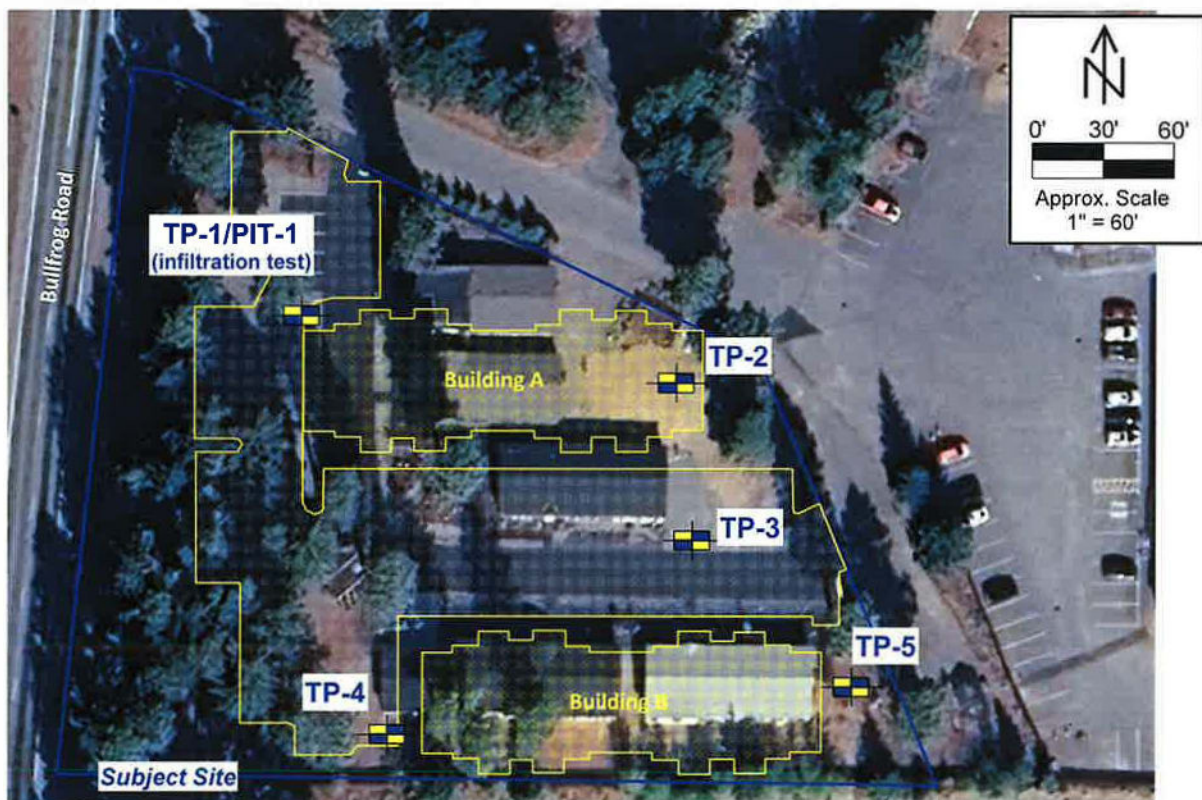
Figure No. **2**

Notes: Base map obtained from Google Earth. Proposed building layout 'Option B'.

- Figure 1 Vicinity Map  
Figure 2 Site and Exploration Plan

Five test pits (TP-1 through TP-5) were excavated at the subject site on June 25, 2024, to evaluate subsurface conditions. The approximate test pit locations are indicated in Figure 2. The test pits were excavated up to 9 feet below the existing ground surface using a Kubota U27 rubber tracked mini-excavator owned and operated by Tamarack Trail Builders of Roslyn, Washington.

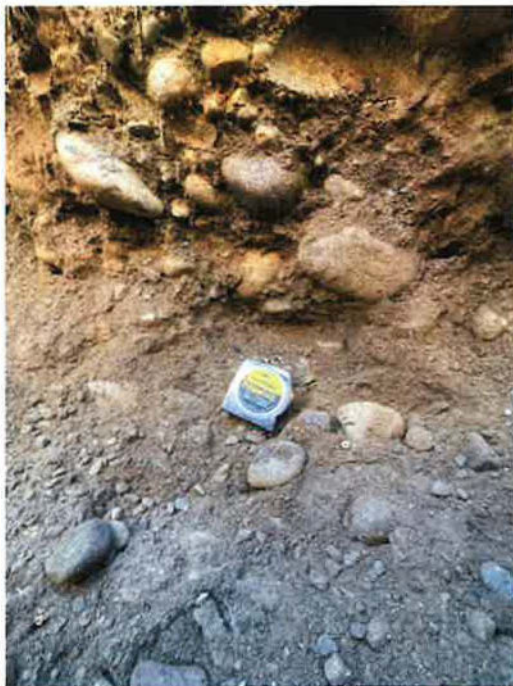
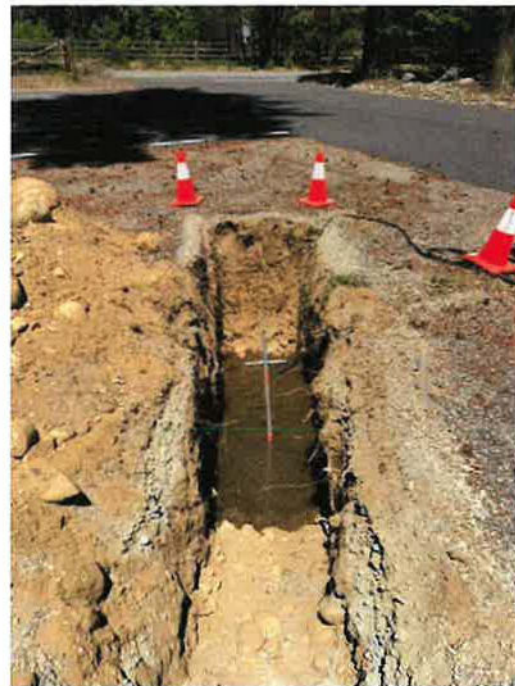
## Test Pit No. TP-1 (PIT-1)

| Depth (ft) | Material Description |
|---|---|
| 4.5 – 9 | <p>Medium dense to dense, brown, poorly graded GRAVEL with silt and sand, moist.</p> <ul style="list-style-type: none"> <li>Small-scale Pilot Infiltration Test conducted about 5 feet below grade</li> <li><b>Sample at 5:</b> 5.0% fines (GP-GM)</li> <li>Numerous cobbles, occasional small boulders</li> <li>Minor caving</li> </ul> |

**Left Photo:** Tape measure at about 5 feet below grade. **Right Photo:** Infiltration test in progress.

TP-1 was terminated approximately 9 feet below grade at the conclusion of infiltration testing. Groundwater was not encountered at the time of excavation.

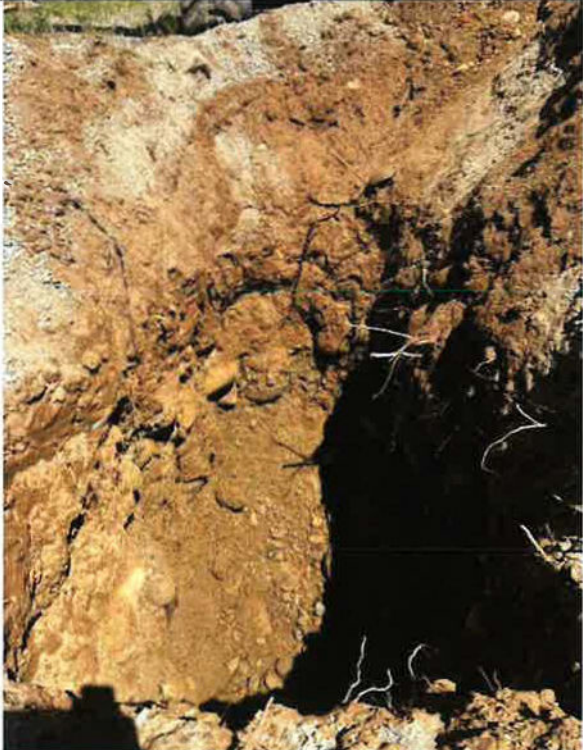
| Test Pit No. TP-3 | |
|---|---|
| 3.5 – 9 | Dense, brown, well to poorly graded GRAVEL with sand, moist. <ul style="list-style-type: none"> <li>Numerous cobbles, occasional small boulders</li> <li><b>Sample at 5':</b> 4.4% fines (GW)</li> <li><b>Sample at 8.5':</b> 4.1% fines (GP)</li> </ul> |
| <p><b>Photo:</b> Test pit around 7 feet deep.</p> <p>TP-3 was terminated approximately 9 feet below grade due to practical excavation refusal on a boulder. Groundwater was not encountered at the time of excavation.</p> <p><b>Logged by:</b> S Swenson</p> | |

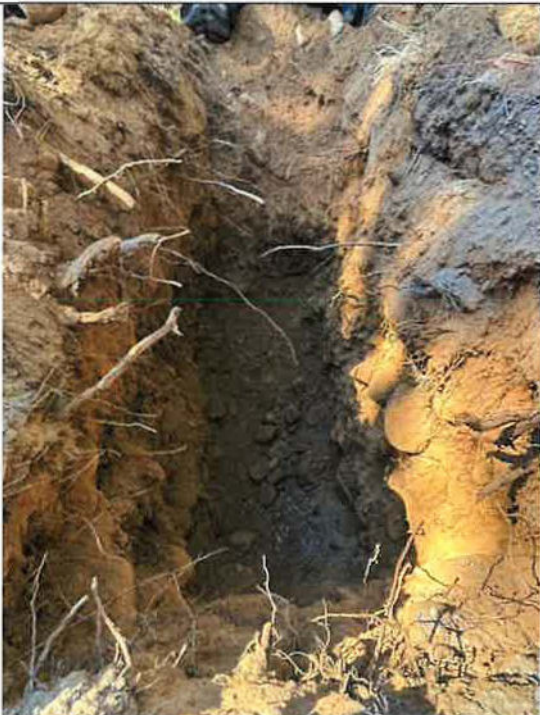
| Test Pit No. TP-4 | |
|---|---|
| 4 – 8 | Medium dense to dense, brown, well to poorly graded GRAVEL with sand, moist. <ul style="list-style-type: none"> <li>Numerous cobbles, occasional small boulders</li> </ul> |
| <p><b>Photo:</b> Completed test pit.</p> <p>TP-4 was terminated approximately 8 feet below grade. Groundwater was not encountered at the time of excavation.</p> <p><b>Logged by:</b> S Swenson</p> | |

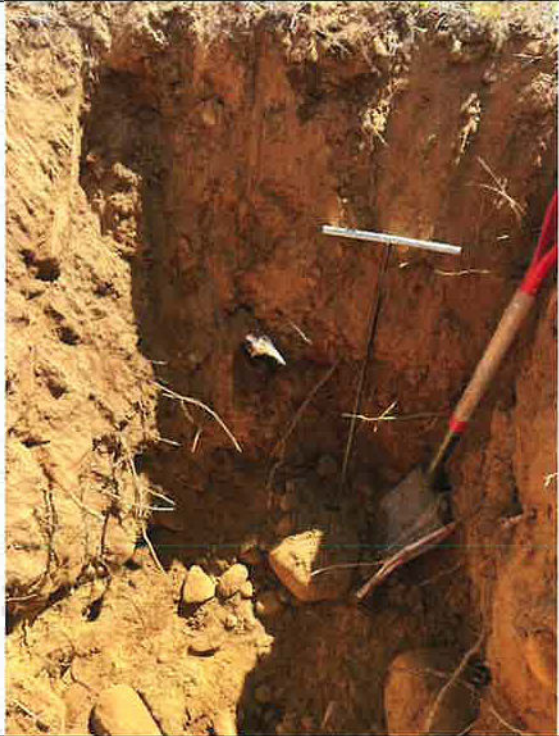
| Test Pit No. TP-5 | |
|---|---|
| 4 – 6.5 | Medium dense to dense, brown, poorly graded GRAVEL with silt and sand, moist. [Alluvium] <ul style="list-style-type: none"> <li>Numerous cobbles, occasional small boulders</li> <li>Sample at 6': 5.5% fines</li> </ul> |
| <p><b>Photo:</b> Test pit at 5 feet.</p> <p>TP-5 was terminated approximately 6.5 feet below grade. Groundwater was not encountered at the time of excavation.</p> <p><b>Logged by:</b> S Swenson</p> | |

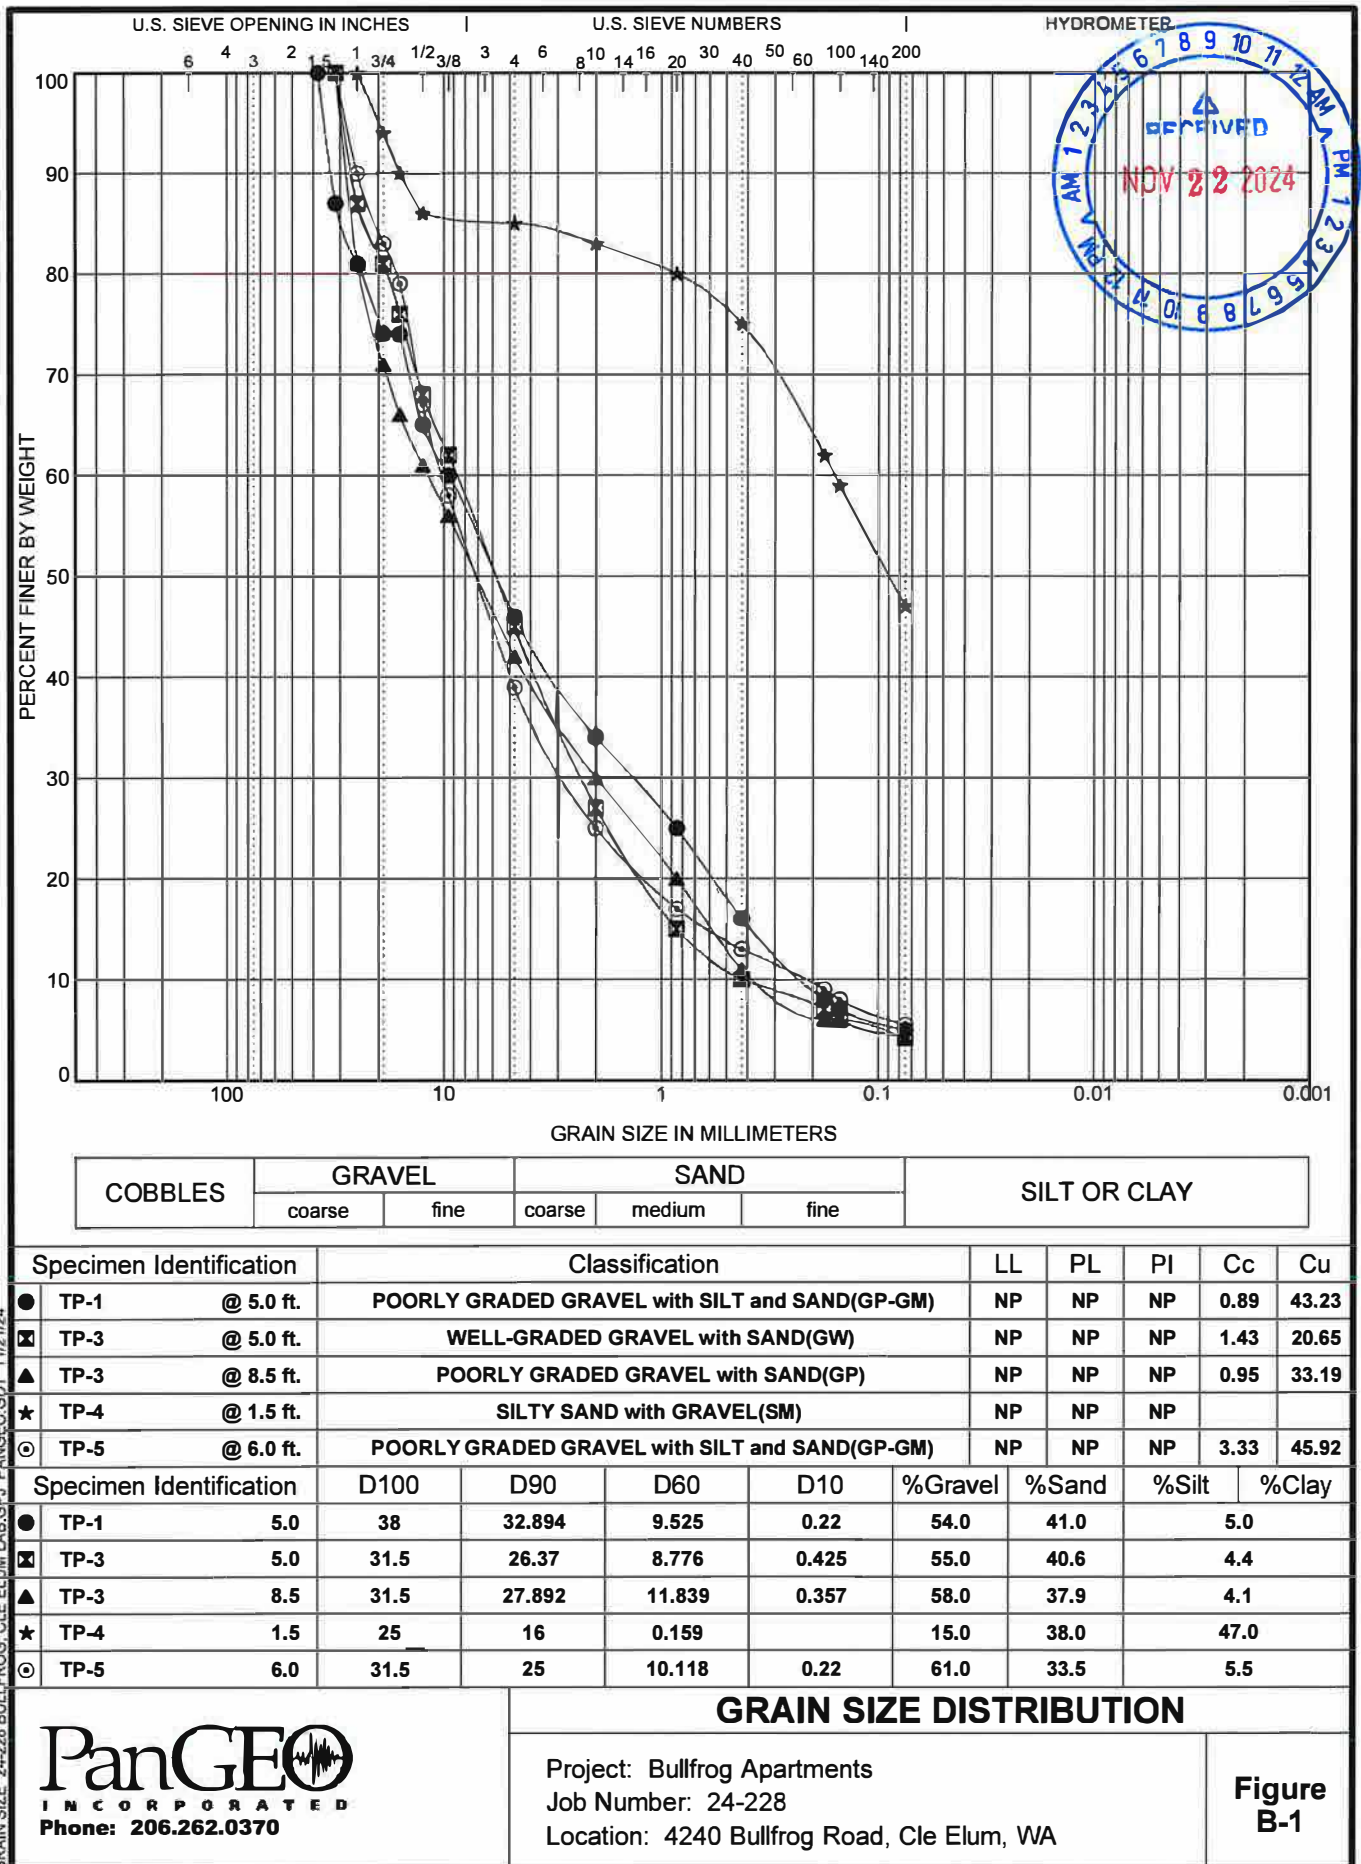
# **GEOTECHNICAL LABORATORY TEST RESULTS**
