Technical Report: Geology, Soils, and Groundwater

47° NORTH MASTER SITE PLAN SUPPLEMENTAL ENVIRONMENTAL IMPACT STATEMENT

Cle Elum, Washington

September 2020

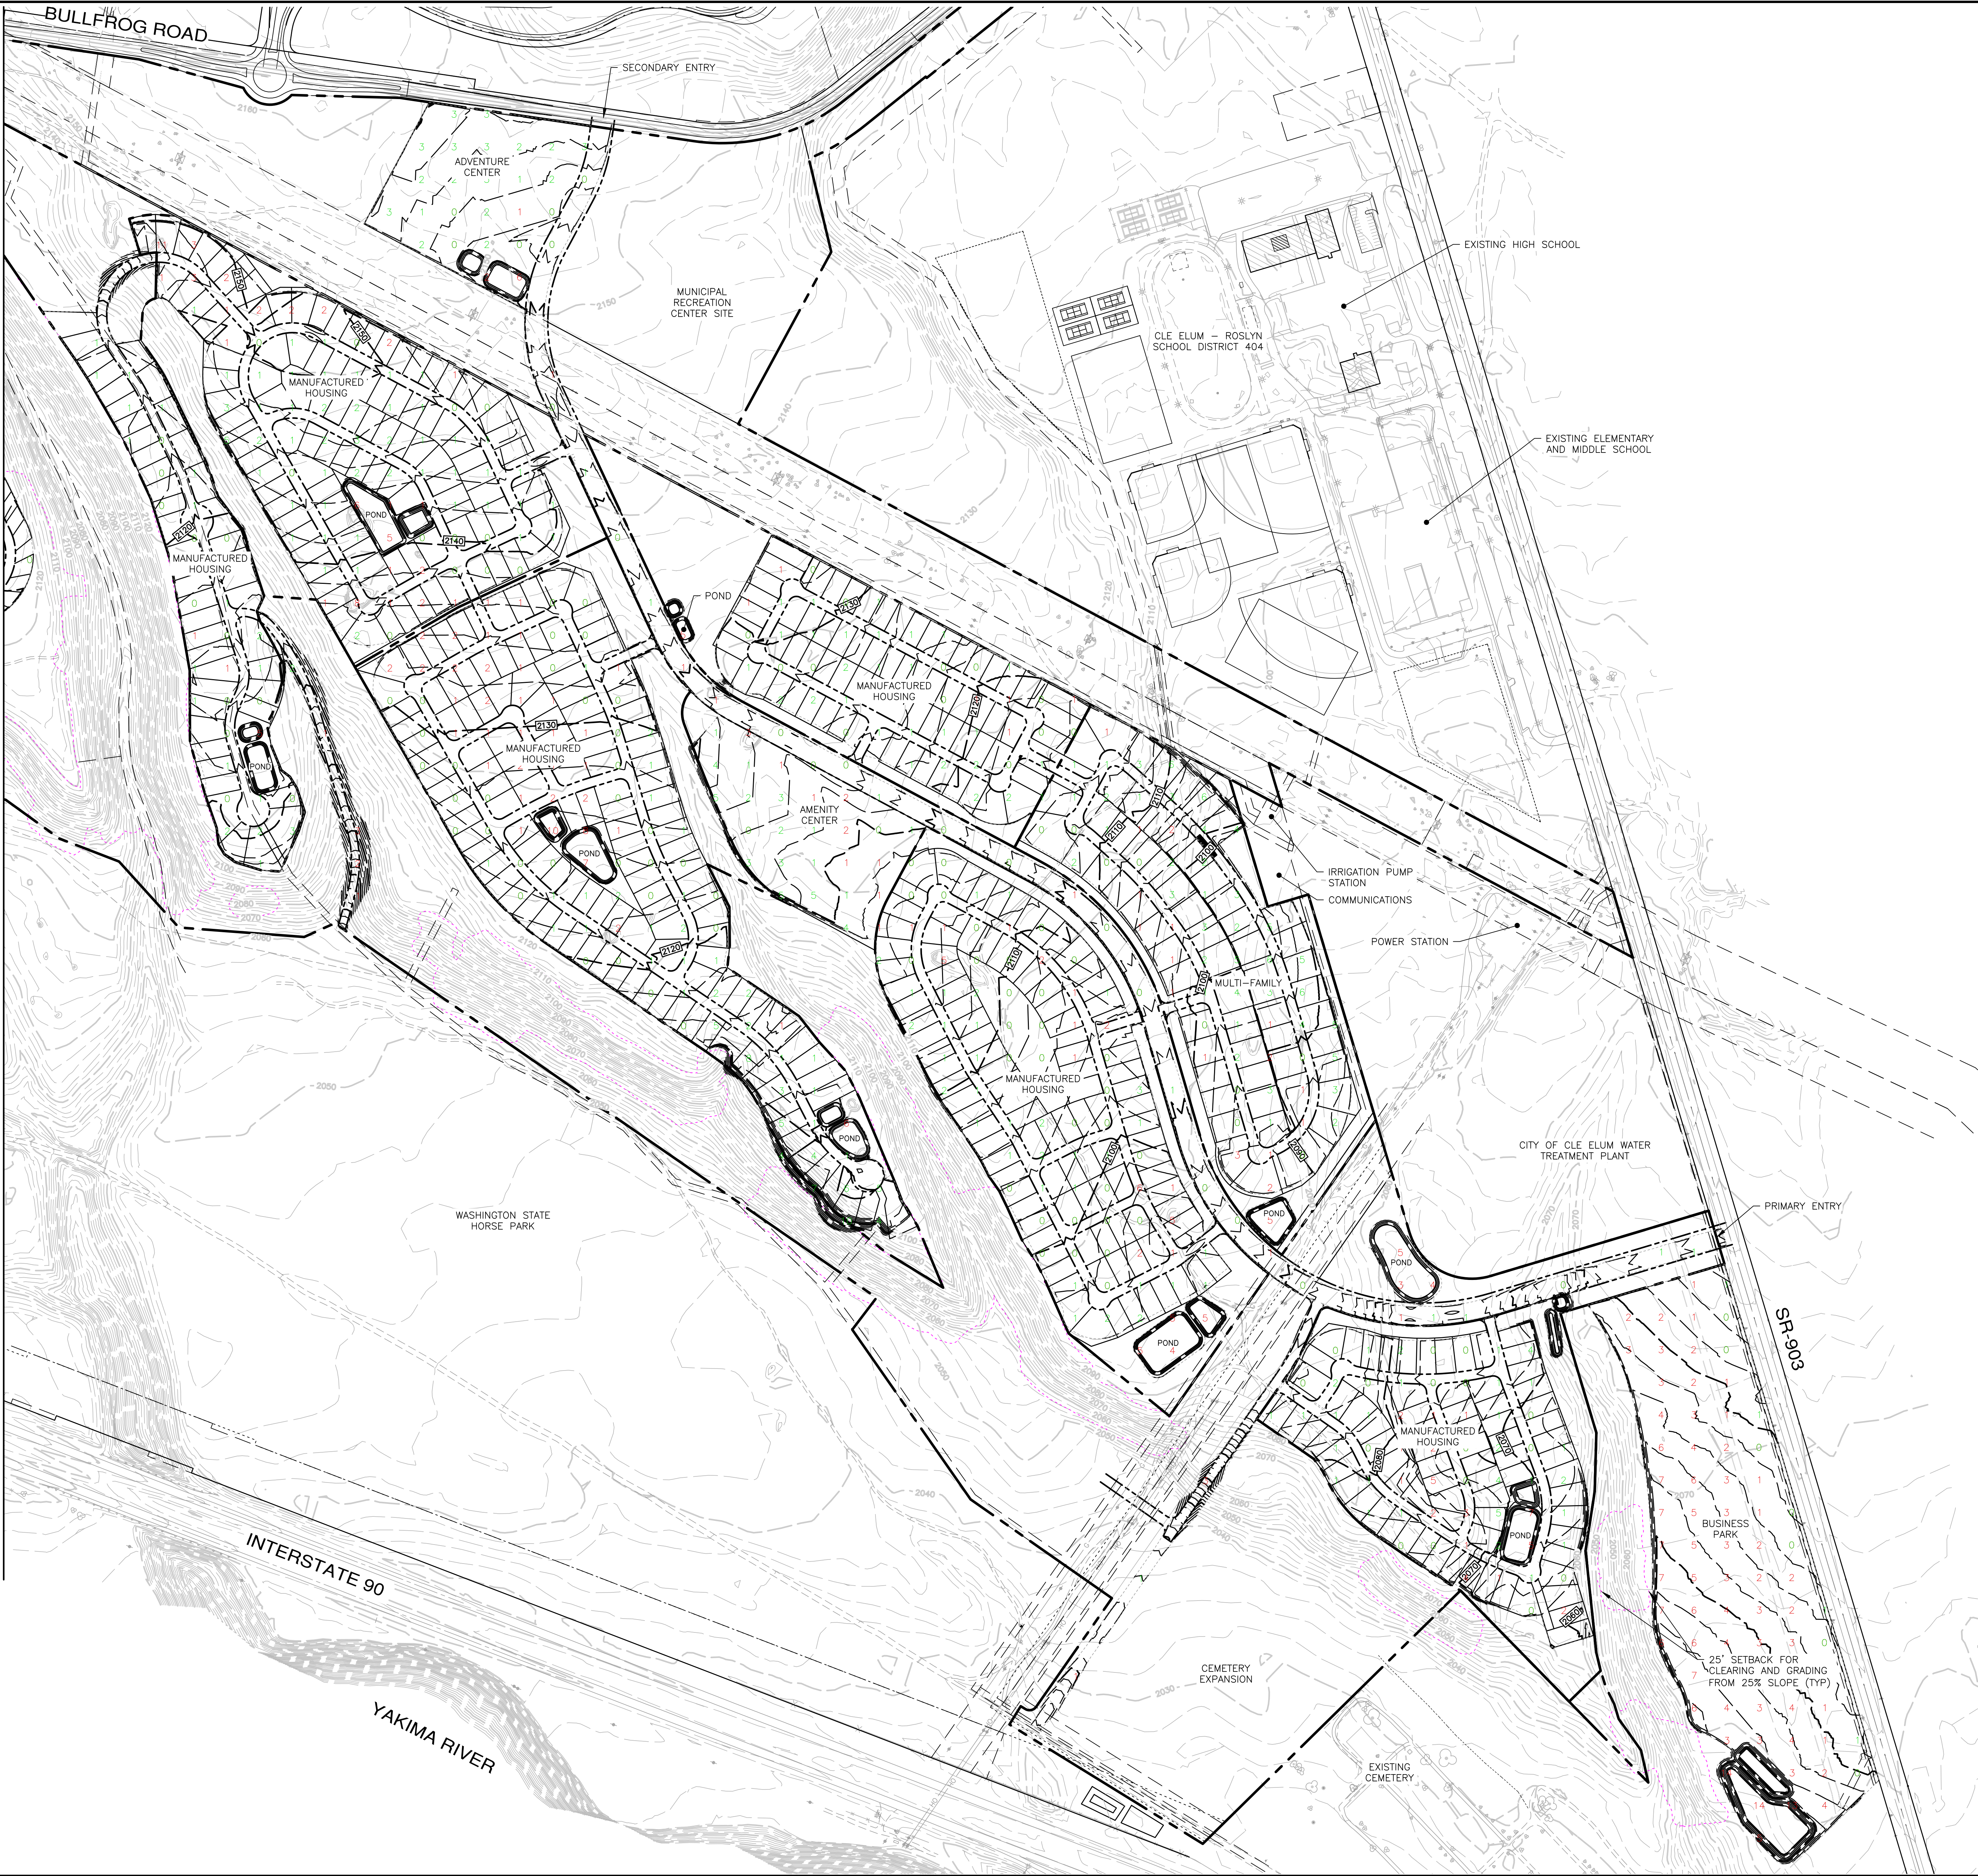
PRELIMINARY GRADING VOLUMES

RV & REC-1 UNITS
CUT: 116,741 CY
FILL: 110,122 CY
NET: 6,619 CY (CUT)
12" STRIPPING: 138,389 CY
