RE: **City Heights Wetlands and Wildlife Report Addendum  
SWC Job#A9-121**

This letter is an Addendum to our October 26, 2009, "*City Heights, City of Cle Elum Wetlands and Wildlife Habitat Report*". Specifically, this letter is in response to additional site work we have conducted regarding 'Stream E' as described in the above report. A closer analysis of this feature during several subsequent site visits has revealed that its character and size may be much smaller, and different than previously described.

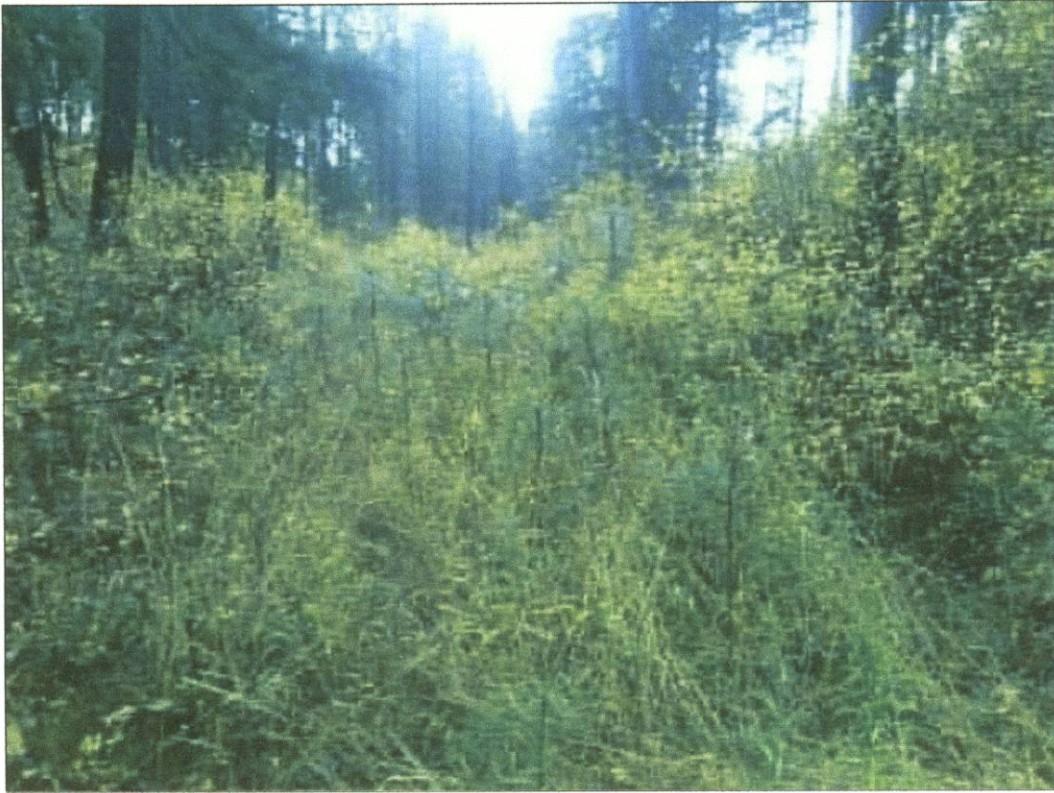
Our work was originally conducted in the summer of 2009, at which time no water or evidence of water was observed in this feature. That was the dry season, so this might be expected for an intermittently-flowing channel. Although the "Stream E" feature is located within a natural ravine-type landform, the "channel" itself is highly modified. Upon closer inspection, it is clear that the area of this feature is an old skid road that has become overgrown. A tire rut formed throughout the western edge of this feature was previously identified as a channel. Just off-site to the south, the feature appears to have a more natural stream-like channel prior to being directed through an 18-inch diameter wood pipe culvert under a gravel roadbed. This culvert was observed to be totally plugged and showing no evidence of any water passing through it in recent time. It is possible this culvert was just placed to allow seasonal snowmelt to pass under the road.

It is our belief that based upon these new observations, the feature previously identified as "Stream E" may not actually carry any water on an annual basis, and may not truly meet the definition of a stream. If it does carry water within the rutted channel, it may only be at the time of occasional snow melts and may be much shorter in length than originally identified, possibly all located off-site to the south.

*Above: A view of the feature previously identified as "Stream E". As can be seen in this photo, the old roadbed can still be distinguished and is being overgrown with upland species such as Ponderosa Pine seedlings.*

It is our intent to monitor this channel over the winter and spring of 2010–2011 to see if it actually carries any water. If it does not, we will document our findings and have the stream removed from the City Heights site plan. If it does carry water, or if the length of flow is shorter than previously identified, we will modify our findings based upon these results.
