*Technical Report: Geology, Soils, and Groundwater*

**47° NORTH MASTER SITE PLAN**  
**SUPPLEMENTAL ENVIRONMENTAL IMPACT STATEMENT**  
Cle Elum, Washington

Project No. 20190414H001

September 2020

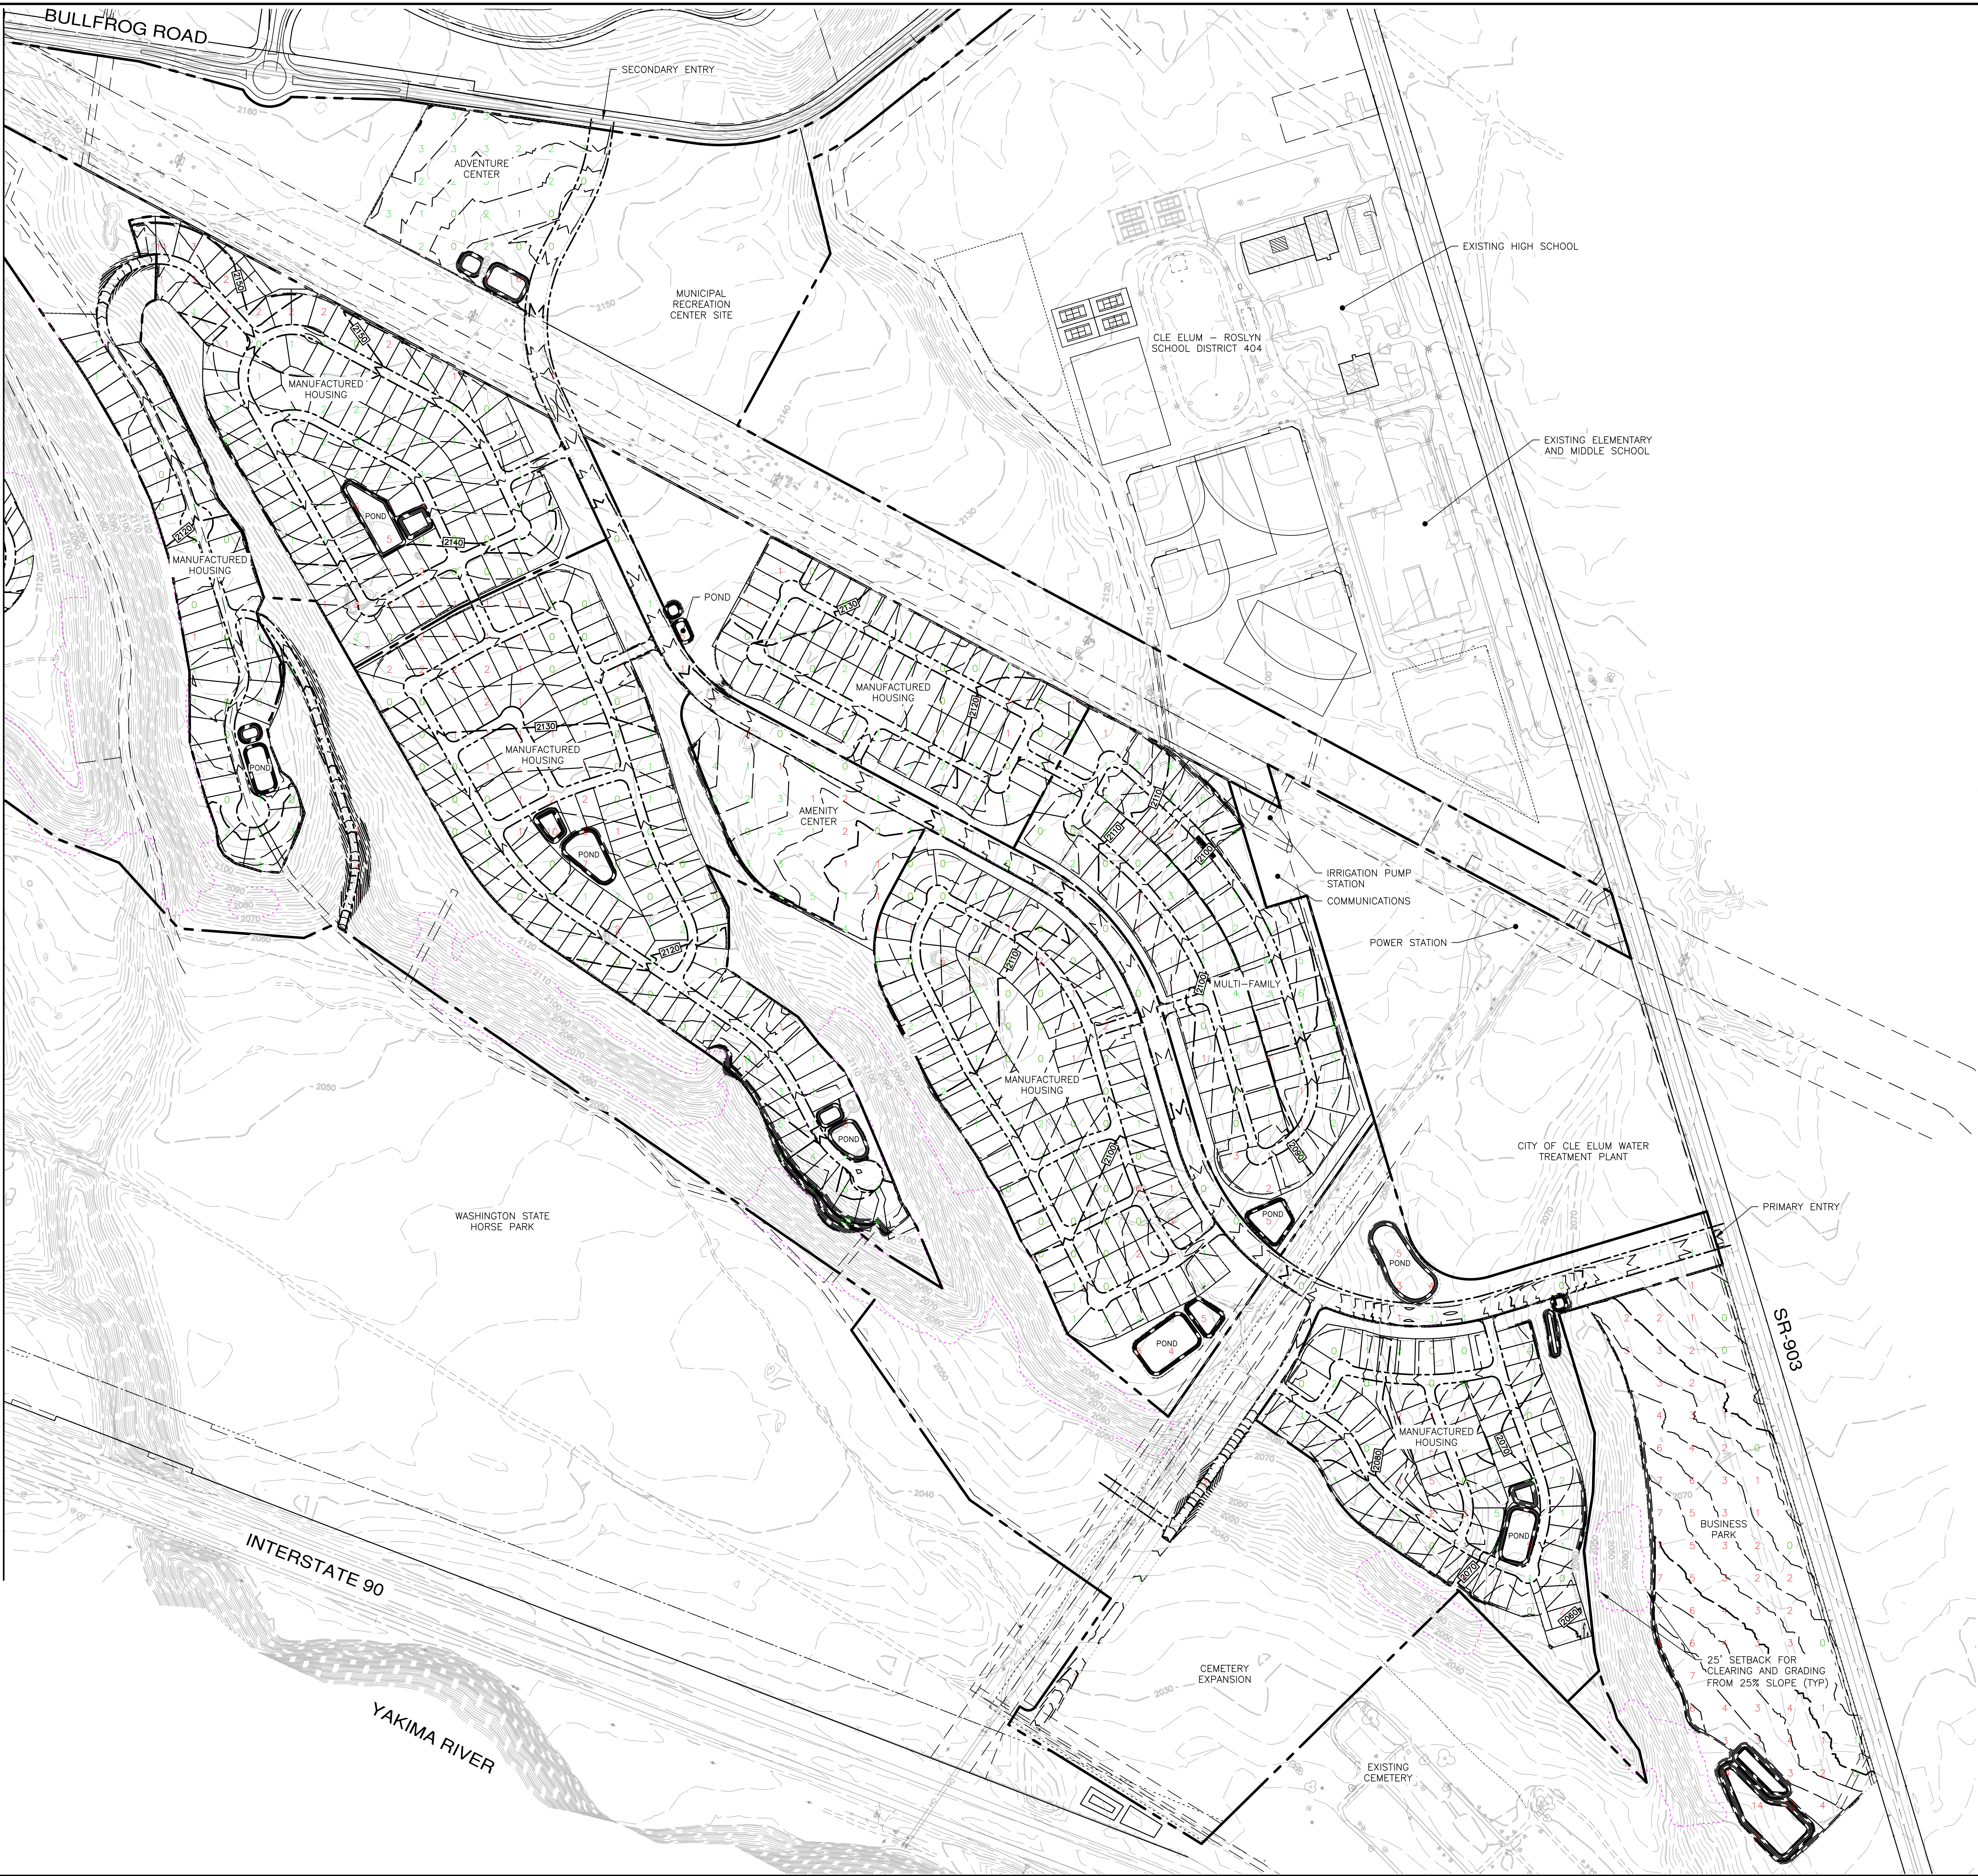
**PRELIMINARY GRADING VOLUMES**

**RV & REC-1 UNITS**  
CUT: 116,741 CY  
FILL: 110,122 CY  
NET: 6,619 CY (CUT)  
12" STRIPPING: 138,389 CY

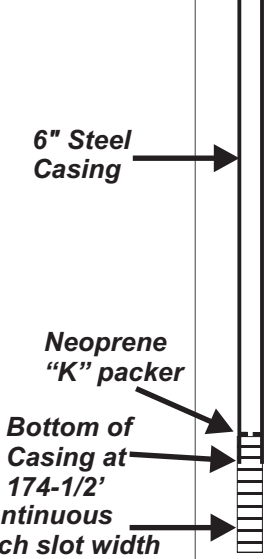
6" Steel Casing  Neoprene "K" packer Bottom of Casing at 174-1/2' 5" Stainless steel continuous slot screen; 0.010-inch slot width		
	170	Gray, sandy SILT, occasional gravel			
	180	Gray, silty, fine to medium quartz and basaltic SAND			
	BOH @ 180'				
	190				
	200
